Manhole Inspection Report

Date:	05/08/2018	Weather:		Coding:	RZMACP
MH#:	M-1004-011	Owner:	NA	Len. Surveyed:	5.7
P.O.#:		Surveyor:	Jen Costello	Rim to Invert:	6.2
Customer:		Cert. #:	U-907-5518	Wall Material:	Concrete (reinforced)

Street:	Intersection of McAfee Ct. and McAf	Project:	Hobart, IN
City:	Hobart, IN	GPS Northing:	2914505.321
Location:		GPS Easting:	2914505.321
Drain Area:	Northeast	GPS Accuracy:	Sub-Meter
Cover Shape:	Circular	Evidence of Surcharge:	No
Cover Size:	22.5	Potential for Runoff:	None
Comments:

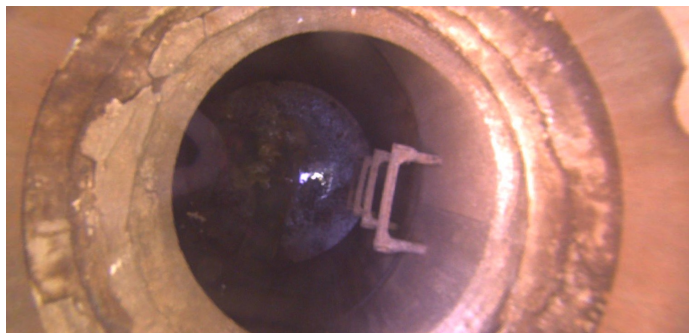
Code: **MGP**
Description: **General Photo**

Distance (ft): **.0**
Structural Grade: **0**
O&M Grade: **0**
Clock Start/From:
Clock To:
1st Value:
2nd Value:
Value Percent:
Step: **NO**
Remarks: **ACCESS MH**

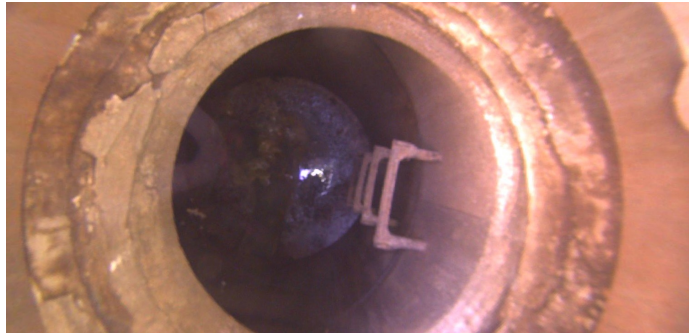
O&M Index:	0.00	O&M Quick:	0000	O&M Rating:	0.00
Structural Index:	4.00	Structural Quick:	4100	Structural Rating:	4.00
Overall Index:	4.00	Overall Quick:	4100	Overall Rating:	4.00

Code: **FM**
Description: **Fracture Multiple**

Distance (ft): **.0**
Structural Grade: **4**
O&M Grade: **0**
Clock Start/From: **9**
Clock To: **11**
1st Value:
2nd Value:
Value Percent:
Step: **NO**
Remarks:

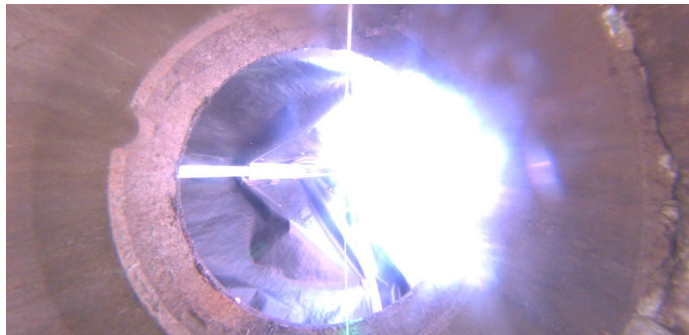
Code: **MGO**
Description: **General Observation**

Distance (ft): **1.7**
Structural Grade: **0**
O&M Grade: **0**
Clock Start/From:
Clock To:
1st Value:
2nd Value:
Value Percent:
Step: **NO**
Remarks: **UNDERSIDE OF FRAME**

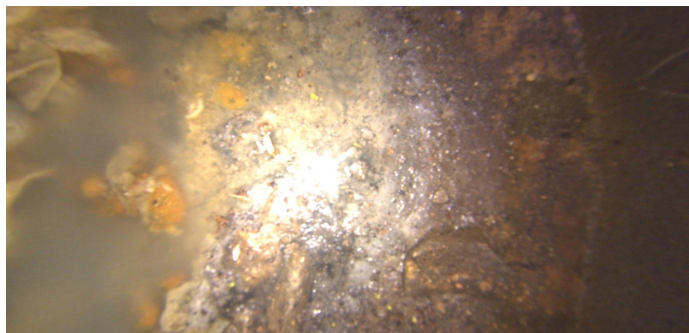
Code: **MGO**
Description: **General Observation**

Distance (ft): **5.7**
Structural Grade: **0**
O&M Grade: **0**
Clock Start/From:
Clock To:
1st Value:
2nd Value:
Value Percent:
Step: **NO**
Remarks: **END SURVEY**
