Manhole Inspection Report

Date:	05/08/2018	Weather:		Coding:	RZMACP
MH#:	M-1004-012	Owner:	NA	Len. Surveyed:	6.1
P.O.#:		Surveyor:	Jen Costello	Rim to Invert:	6.1
Customer:		Cert. #:	U-907-5518	Wall Material:	Concrete (reinforced)

Street:	McAfee Ct.	Project:	Hobart, IN
City:	Hobart, IN	GPS Northing:	2914664.362
Location:		GPS Easting:	2914664.362
Drain Area:	Northeast	GPS Accuracy:	Sub-Meter
Cover Shape:	Circular	Evidence of Surcharge:	No
Cover Size:	22.5	Potential for Runoff:	None
Comments:

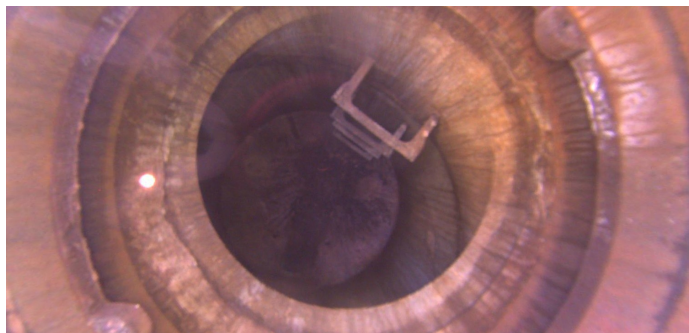
Code: **MGP**
Description: **General Photo**

Distance (ft): **.0**
Structural Grade: **0**
O&M Grade: **0**
Clock Start/From:
Clock To:
1st Value:
2nd Value:
Value Percent:
Step: **NO**
Remarks: **ACCESS MH**

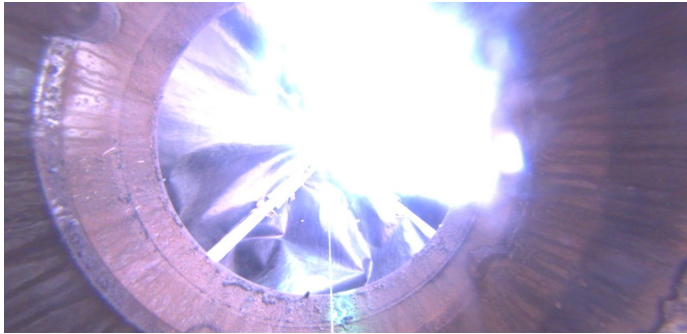
Code:	MGO
Description:	General Observation
Distance (ft):	1.8
Structural Grade:	0
O&M Grade:	0
Clock Start/From:	
Clock To:	
1st Value:	
2nd Value:	
Value Percent:	
Step:	NO
Remarks:	UNDERSIDE OF FRAME

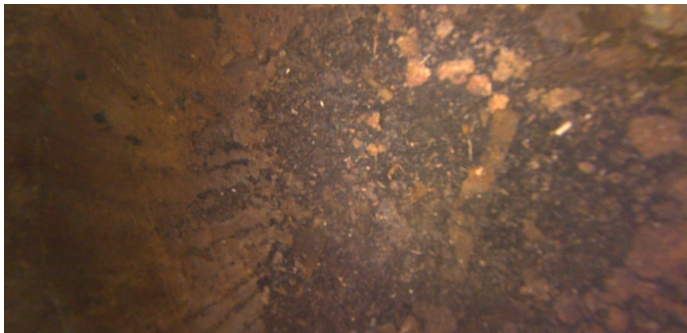
Code:	DSF
Description:	Deposits Settled Fine
Distance (ft):	5.3
Structural Grade:	0
O&M Grade:	2
Clock Start/From:	12
Clock To:	12
1st Value:	
2nd Value:	
Value Percent:	5.000
Step:	NO
Remarks:

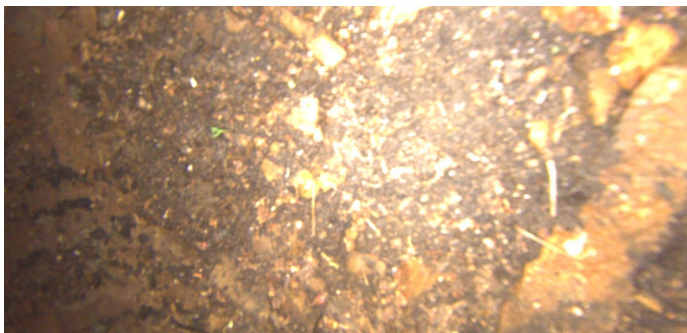
Code:	MGO
Description:	General Observation
Distance (ft):	6.1
Structural Grade:	0
O&M Grade:	0
Clock Start/From:	
Clock To:	
1st Value:	
2nd Value:	
Value Percent:	
Step:	NO
Remarks:	END SURVEY
