# Manhole Inspection Report

Date:	<b>05/08/2018</b>	Weather:		Coding:	<b>RZMACP</b>
MH#:	<b>M-1004-014</b>	Owner:	<b>NA</b>	Len. Surveyed:	<b>7.0</b>
P.O.#:		Surveyor:	<b>Jen Costello</b>	Rim to Invert:	<b>7.4</b>
Customer:		Cert. #:	<b>U-907-5518</b>	Wall Material:	<b>Concrete (reinforced)</b>

Street:	<b>McAfee Dr. 180' East of Eastin Ave.</b>	Project:	<b>Hobart, IN</b>
City:	<b>Hobart, IN</b>	GPS Northing:	<b>2914361.418</b>
Location:		GPS Easting:	<b>2914361.418</b>
Drain Area:	<b>Northeast</b>	GPS Accuracy:	<b>Sub-Meter</b>
Cover Shape:	<b>Circular</b>	Evidence of Surcharge:	<b>No</b>
Cover Size:	<b>22.5</b>	Potential for Runoff:	<b>None</b>
Comments:

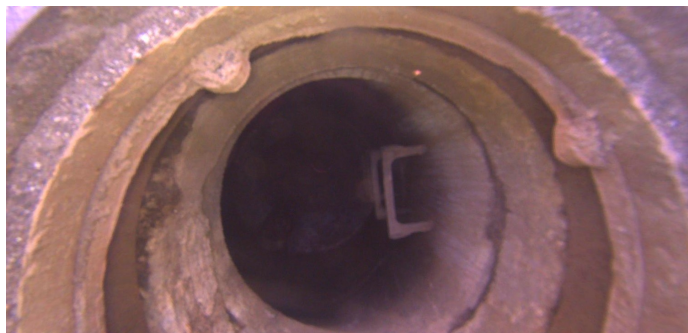
Code: **MGP**  
Description: **General Photo**

Distance (ft): **.0**  
Structural Grade: **0**  
O&M Grade: **0**  
Clock Start/From:  
Clock To:  
1st Value:  
2nd Value:  
Value Percent:  
Step: **NO**  
Remarks: **ACCESS MH**

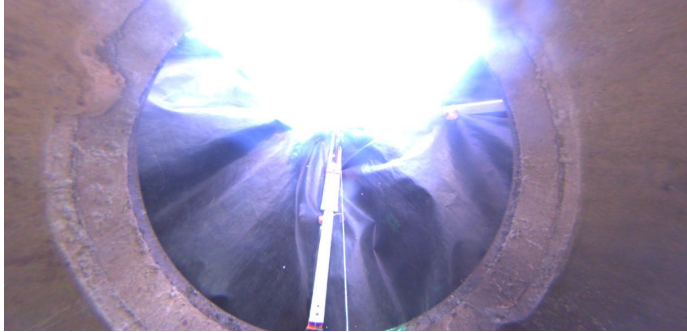
Code:	<b>MGO</b>
Description:	<b>General Observation</b>
Distance (ft):	<b>1.6</b>
Structural Grade:	<b>0</b>
O&M Grade:	<b>0</b>
Clock Start/From:	
Clock To:	
1st Value:	
2nd Value:	
Value Percent:	
Step:	<b>NO</b>
Remarks:	<b>UNDERSIDE OF FRAME</b>

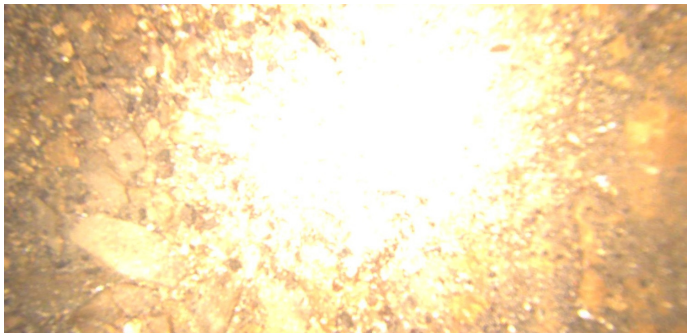
Code:	<b>MGO</b>
Description:	<b>General Observation</b>
Distance (ft):	<b>7.0</b>
Structural Grade:	<b>0</b>
O&M Grade:	<b>0</b>
Clock Start/From:	
Clock To:	
1st Value:	
2nd Value:	
Value Percent:	
Step:	<b>NO</b>
Remarks:	<b>END SURVEY</b>
