Manhole Inspection Report

Date:	05/08/2018	Weather:		Coding:	RZMACP
MH#:	M-1004-019	Owner:	NA	Len. Surveyed:	8.0
P.O.#:		Surveyor:	Jen Costello	Rim to Invert:	8.7
Customer:		Cert. #:	U-907-5518	Wall Material:	Concrete (reinforced)

Street:	Drexel Dr. and Coral Dr. the Third on	Project:	Hobart, IN
City:	Hobart, IN	GPS Northing:	2914133.85
Location:		GPS Easting:	2914133.85
Drain Area:	Northeast	GPS Accuracy:	Sub-Meter
Cover Shape:	Circular	Evidence of Surcharge:	No
Cover Size:	22.5	Potential for Runoff:	None
Comments:

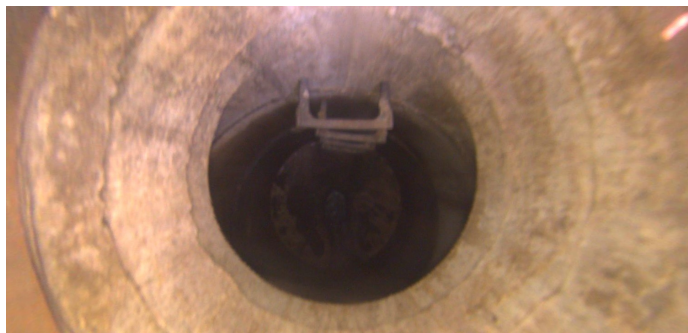
Code: **MGP**
Description: **General Photo**

Distance (ft): **.0**
Structural Grade: **0**
O&M Grade: **0**
Clock Start/From:
Clock To:
1st Value:
2nd Value:
Value Percent:
Step: **NO**
Remarks: **ACCESS MH**

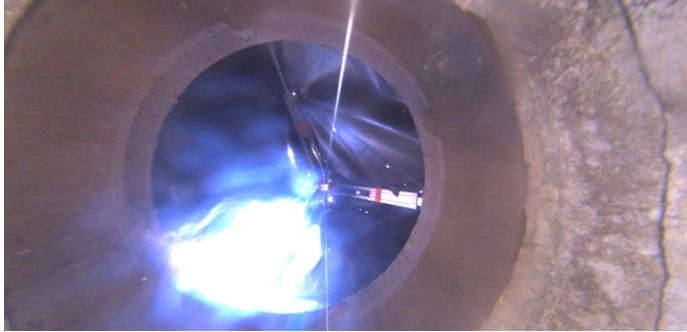
Code:	MGP
Description:	General Photo
Distance (ft):	1.7
Structural Grade:	0
O&M Grade:	0
Clock Start/From:	
Clock To:	
1st Value:	
2nd Value:	
Value Percent:	
Step:	NO
Remarks:	UNDERSIDE OF FRAME

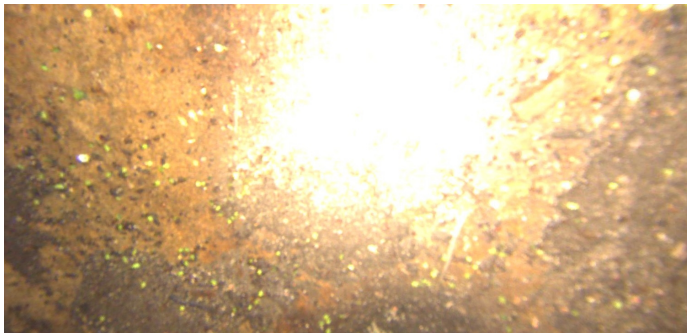
Code:	MGO
Description:	General Observation
Distance (ft):	8.0
Structural Grade:	0
O&M Grade:	0
Clock Start/From:	
Clock To:	
1st Value:	
2nd Value:	
Value Percent:	
Step:	NO
Remarks:	END SURVEY
