Manhole Inspection Report

Date:	05/08/2018	Weather:		Coding:	RZMACP
MH#:	M-1004-021	Owner:	NA	Len. Surveyed:	6.6
P.O.#:		Surveyor:	Jen Costello	Rim to Invert:	7.5
Customer:		Cert. #:	U-907-5518	Wall Material:	Concrete (reinforced)

Street:	Drexel Dr. Second Manhole to Flow	Project:	Hobart, IN
City:	Hobart, IN	GPS Northing:	41.53820801
Location:		GPS Easting:	-87.22543335
Drain Area:	Northeast	GPS Accuracy:	Nearest Meter
Cover Shape:	Circular	Evidence of Surcharge:	No
Cover Size:	22.5	Potential for Runoff:	None
Comments:

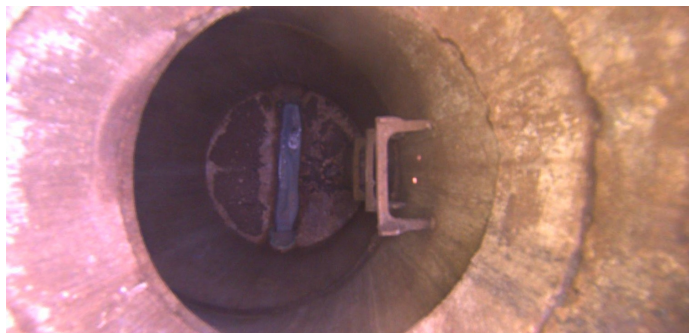
Code: **MGP**
Description: **General Photo**

Distance (ft): **.0**
Structural Grade: **0**
O&M Grade: **0**
Clock Start/From:
Clock To:
1st Value:
2nd Value:
Value Percent:
Step: **NO**
Remarks: **ACCESS MH**

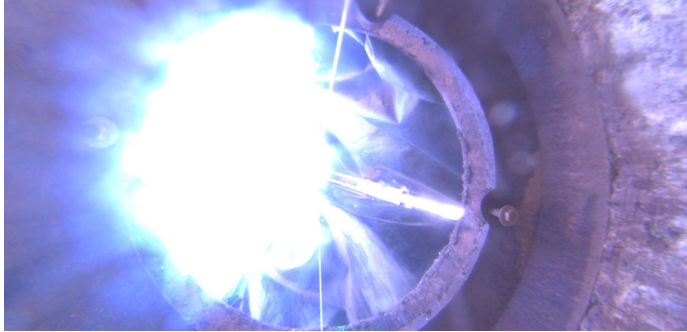
Code:	MGO
Description:	General Observation
Distance (ft):	1.2
Structural Grade:	0
O&M Grade:	0
Clock Start/From:	
Clock To:	
1st Value:	
2nd Value:	
Value Percent:	
Step:	NO
Remarks:	UNDERSIDE OF FRAME

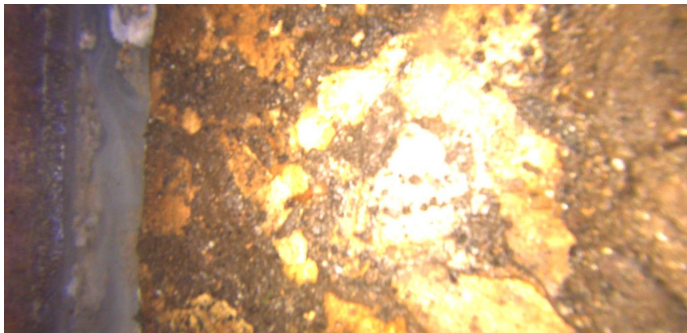
Code:	MGO
Description:	General Observation
Distance (ft):	6.6
Structural Grade:	0
O&M Grade:	0
Clock Start/From:	
Clock To:	
1st Value:	
2nd Value:	
Value Percent:	
Step:	NO
Remarks:	END SURVEY
