# Manhole Inspection Report

Date:	05/08/2018	Weather:		Coding:	RZMACP
MH#:	M-1004-021	Owner:	NA	Len. Surveyed:	7.4
P.O.#:		Surveyor:	Jen Costello	Rim to Invert:	7.8
Customer:		Cert. #:	U-907-5518	Wall Material:	Concrete (reinforced)

Street:	Drexel Dr. Second Manhole to Flow	Project:	Hobart, IN
City:	Hobart, IN	GPS Northing:	41.53821182
Location:		GPS Easting:	-87.22471619
Drain Area:	Northeast	GPS Accuracy:	Nearest Meter
Cover Shape:	Circular	Evidence of Surcharge:	No
Cover Size:	22.5	Potential for Runoff:	None
Comments:

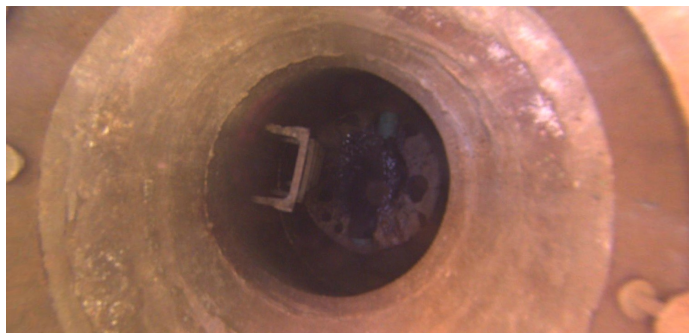
Code: **MGP**  
Description: **General Photo**

Distance (ft): **.0**  
Structural Grade: **0**  
O&M Grade: **0**  
Clock Start/From:  
Clock To:  
1st Value:  
2nd Value:  
Value Percent:  
Step: **NO**  
Remarks: **ACCESS MH**

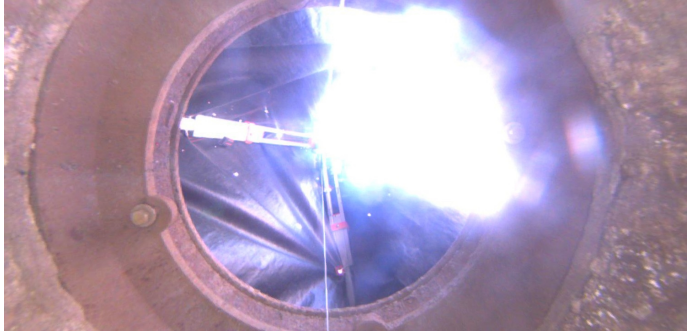
Code: **MGO**  
Description: **General Observation**

Distance (ft): **2.1**  
Structural Grade: **0**  
O&M Grade: **0**  
Clock Start/From:  
Clock To:  
1st Value:  
2nd Value:  
Value Percent:  
Step: **NO**  
Remarks: **UNDERSIDE OF FRAME**

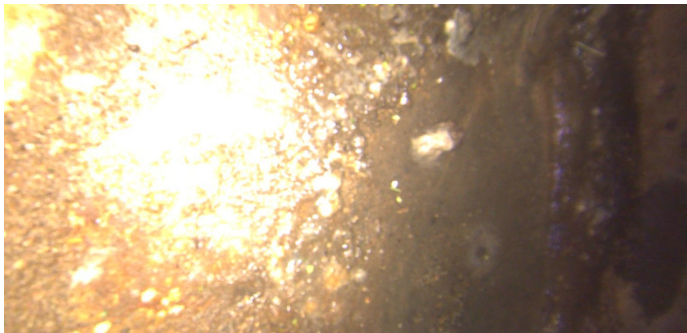
Code: **MGO**  
Description: **General Observation**

Distance (ft): **7.3**  
Structural Grade: **0**  
O&M Grade: **0**  
Clock Start/From:  
Clock To:  
1st Value:  
2nd Value:  
Value Percent:  
Step: **NO**  
Remarks: **END SURVEY**
