# Manhole Inspection Report

Date:	<b>05/08/2018</b>	Weather:		Coding:	<b>RZMACP</b>
MH#:	<b>M-1004-026</b>	Owner:	<b>NA</b>	Len. Surveyed:	<b>7.9</b>
P.O.#:		Surveyor:	<b>Jen Costello</b>	Rim to Invert:	<b>8.8</b>
Customer:		Cert. #:	<b>U-907-5518</b>	Wall Material:	<b>Concrete (reinforced)</b>

Street:	<b>McAfee Dr. 493' West of Eastin Ave.</b>	Project:	<b>Hobart, IN</b>
City:	<b>Hobart, IN</b>	GPS Northing:	<b>2913776.395</b>
Location:		GPS Easting:	<b>2913776.395</b>
Drain Area:	<b>Northeast</b>	GPS Accuracy:	<b>Sub-Meter</b>
Cover Shape:	<b>Circular</b>	Evidence of Surcharge:	<b>No</b>
Cover Size:	<b>22.5</b>	Potential for Runoff:	<b>None</b>
Comments:

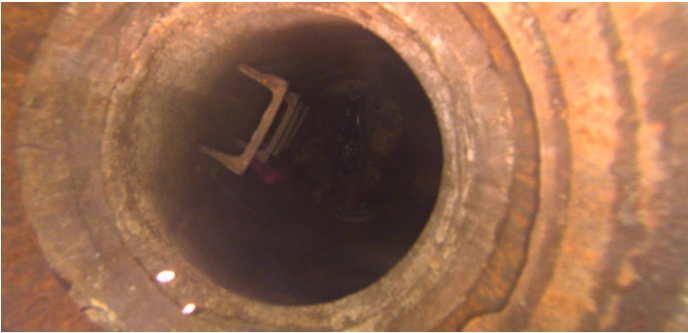
Code:	MGP
Description:	General Photo
Distance (ft):	.0
Structural Grade:	0
O&M Grade:	0
Clock Start/From:	
Clock To:	
1st Value:	
2nd Value:	
Value Percent:	
Step:	NO
Remarks:	ACCESS MH

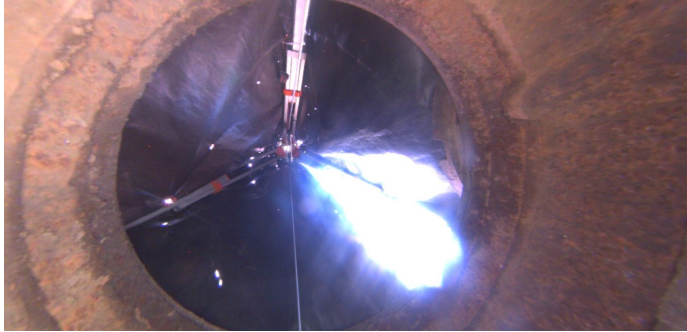
Code: **MGO**  
Description: **General Observation**

Distance (ft): **1.6**  
Structural Grade: **0**  
O&M Grade: **0**  
Clock Start/From:  
Clock To:  
1st Value:  
2nd Value:  
Value Percent:  
Step: **NO**  
Remarks: **END SURVEY**

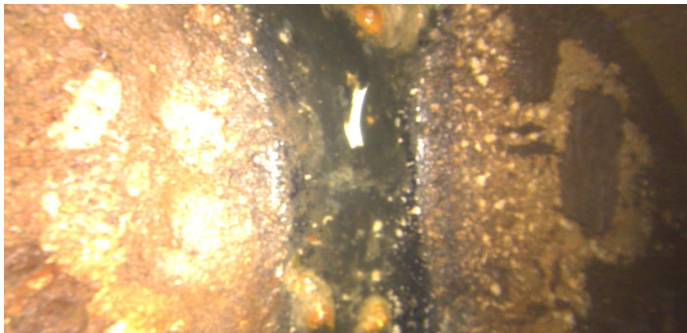
Code: **MGO**  
Description: **General Observation**

Distance (ft): **7.9**  
Structural Grade: **0**  
O&M Grade: **0**  
Clock Start/From:  
Clock To:  
1st Value:  
2nd Value:  
Value Percent:  
Step: **NO**  
Remarks: **END SURVEY**
