Manhole Inspection Report

Date:	05/08/2018	Weather:		Coding:	RZMACP
MH#:	M-1004-027	Owner:	NA	Len. Surveyed:	7.0
P.O.#:		Surveyor:	Jen Costello	Rim to Invert:	7.9
Customer:		Cert. #:	U-907-5518	Wall Material:	Concrete (reinforced)

Street:	Cleveland Ave. 181' West of Eastin A	Project:	Hobart, IN
City:	Hobart, IN	GPS Northing:	2914112.66
Location:		GPS Easting:	2914112.66
Drain Area:	Northeast	GPS Accuracy:	Sub-Meter
Cover Shape:	Circular	Evidence of Surcharge:	No
Cover Size:	22.5	Potential for Runoff:	None
Comments:

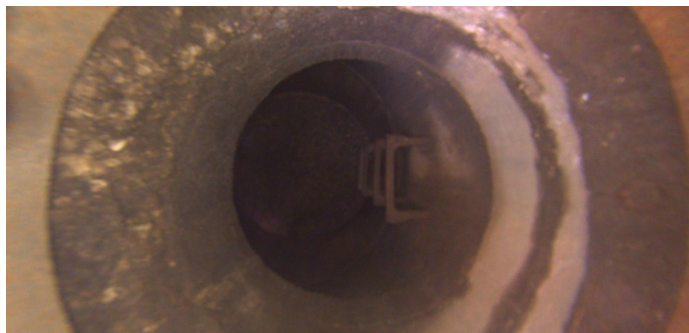
Code: **MGP**
Description: **General Photo**

Distance (ft): **.0**
Structural Grade: **0**
O&M Grade: **0**
Clock Start/From:
Clock To:
1st Value:
2nd Value:
Value Percent:
Step: **NO**
Remarks: **ACCESS MH**

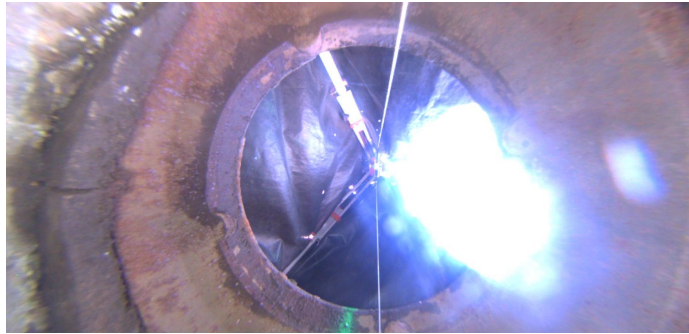
Code:	MGO
Description:	General Observation
Distance (ft):	1.8
Structural Grade:	0
O&M Grade:	0
Clock Start/From:	
Clock To:	
1st Value:	
2nd Value:	
Value Percent:	
Step:	NO
Remarks:	UNDERSIDE OF FRAME

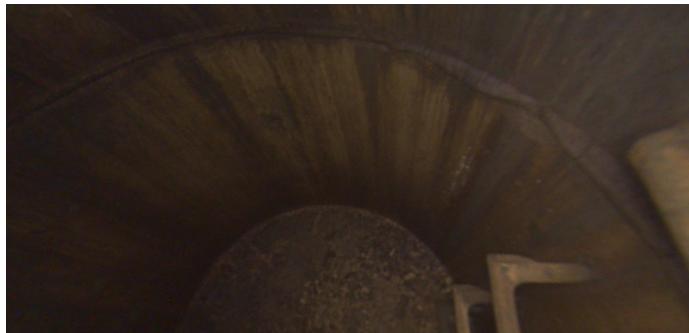
Code:	IS
Description:	Infil Stain
Distance (ft):	3.6
Structural Grade:	0
O&M Grade:	0
Clock Start/From:	10
Clock To:	2
1st Value:	
2nd Value:	
Value Percent:	
Step:	NO
Remarks:

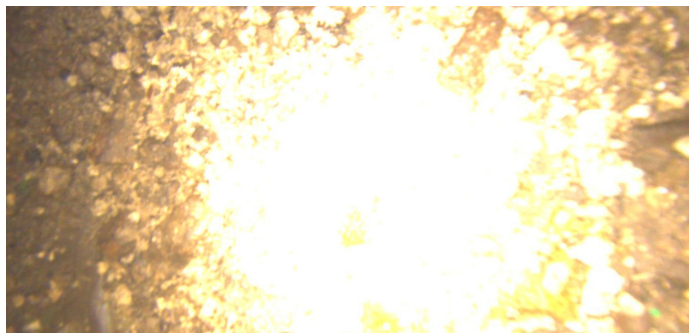
Code:	DSGV
Description:	Deposits Settled Gravel
Distance (ft):	7.0
Structural Grade:	0
O&M Grade:	2
Clock Start/From:	12
Clock To:	12
1st Value:	
2nd Value:	
Value Percent:	10.000
Step:	NO
Remarks:

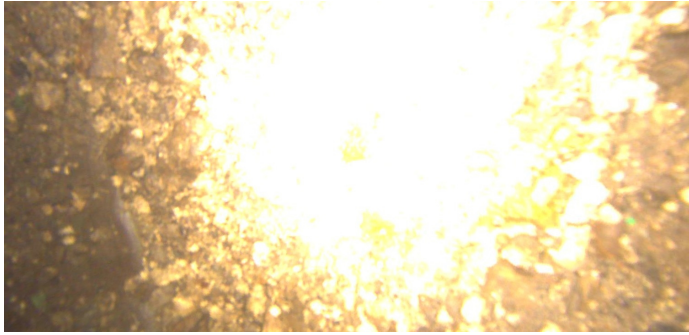
Code:	MGO
Description:	General Observation
Distance (ft):	7.0
Structural Grade:	0
O&M Grade:	0
Clock Start/From:	
Clock To:	
1st Value:	
2nd Value:	
Value Percent:	
Step:	NO
Remarks:	END SURVEY
