Manhole Inspection Report

Date:	05/08/2018	Weather:		Coding:	RZMACP
MH#:	M-1004-030	Owner:	NA	Len. Surveyed:	11.2
P.O.#:		Surveyor:	Jen Costello	Rim to Invert:	12.0
Customer:		Cert. #:	U-907-5518	Wall Material:	Concrete (reinforced)

Street:	Cleveland Ave. 346' East of Hillcrest	Project:	Hobart, IN
City:	Hobart, IN	GPS Northing:	2913106.639
Location:		GPS Easting:	2913106.639
Drain Area:	Northeast	GPS Accuracy:	Sub-Meter
Cover Shape:	Circular	Evidence of Surcharge:	No
Cover Size:	22.5	Potential for Runoff:	None
Comments:

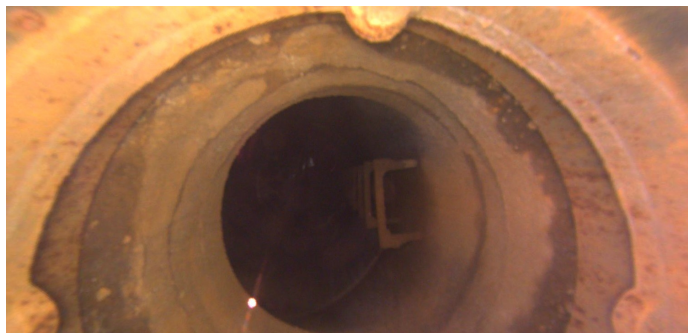
Code: **MGP**
Description: **General Photo**

Distance (ft): **.0**
Structural Grade: **0**
O&M Grade: **0**
Clock Start/From:
Clock To:
1st Value:
2nd Value:
Value Percent:
Step: **NO**
Remarks: **ACCESS MH**

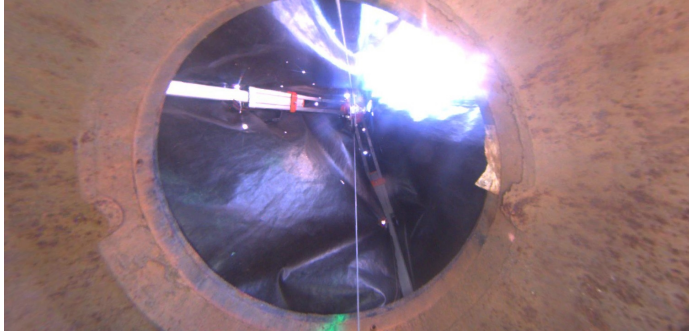
Code:	MGO
Description:	General Observation
Distance (ft):	1.7
Structural Grade:	0
O&M Grade:	0
Clock Start/From:	
Clock To:	
1st Value:	
2nd Value:	
Value Percent:	
Step:	NO
Remarks:	UNDERSIDE OF FRAME

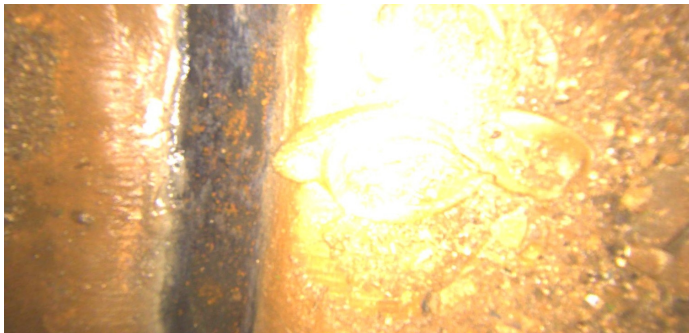
Code:	MGO
Description:	General Observation
Distance (ft):	11.2
Structural Grade:	0
O&M Grade:	0
Clock Start/From:	
Clock To:	
1st Value:	
2nd Value:	
Value Percent:	
Step:	NO
Remarks:	ACCESS MH
