# Manhole Inspection Report

Date:	<b>05/08/2018</b>	Weather:		Coding:	<b>RZMACP</b>
MH#:	<b>M-1004-033</b>	Owner:	<b>NA</b>	Len. Surveyed:	<b>9.3</b>
P.O.#:		Surveyor:	<b>Jen Costello</b>	Rim to Invert:	<b>9.8</b>
Customer:		Cert. #:	<b>U-907-5518</b>	Wall Material:	<b>Concrete (reinforced)</b>

Street:	<b>Drexel Dr. 353' East of Hillcrest Ave.</b>	Project:	<b>Hobart, IN</b>
City:	<b>Hobart, IN</b>	GPS Northing:	<b>2913114.682</b>
Location:		GPS Easting:	<b>2913114.682</b>
Drain Area:	<b>Northeast</b>	GPS Accuracy:	<b>Sub-Meter</b>
Cover Shape:	<b>Circular</b>	Evidence of Surcharge:	<b>No</b>
Cover Size:	<b>22.5</b>	Potential for Runoff:	<b>None</b>
Comments:

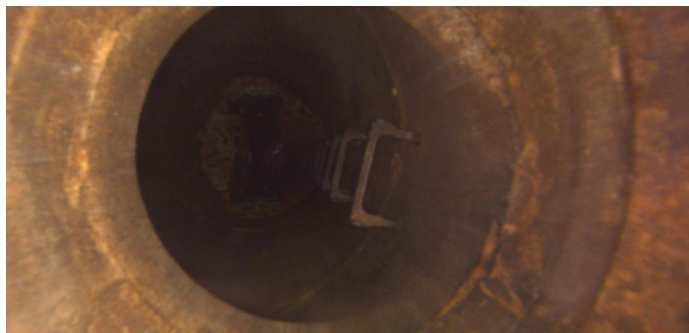
Code: **MGP**  
Description: **General Photo**

Distance (ft): **.0**  
Structural Grade: **0**  
O&M Grade: **0**  
Clock Start/From:  
Clock To:  
1st Value:  
2nd Value:  
Value Percent:  
Step: **NO**  
Remarks: **ACCESS MH**

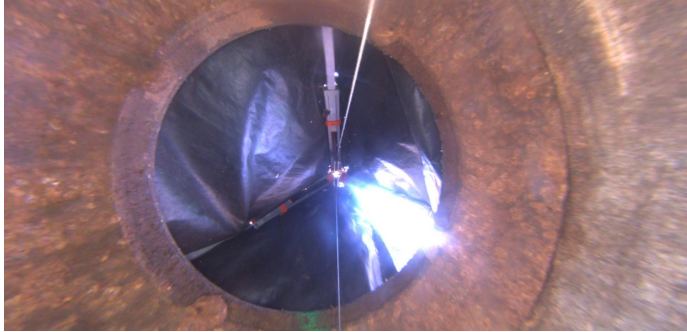
Code:	<b>MGO</b>
Description:	<b>General Observation</b>
Distance (ft):	<b>1.5</b>
Structural Grade:	<b>0</b>
O&M Grade:	<b>0</b>
Clock Start/From:	
Clock To:	
1st Value:	
2nd Value:	
Value Percent:	
Step:	<b>NO</b>
Remarks:	<b>UNDERSIDE OF FRAME</b>

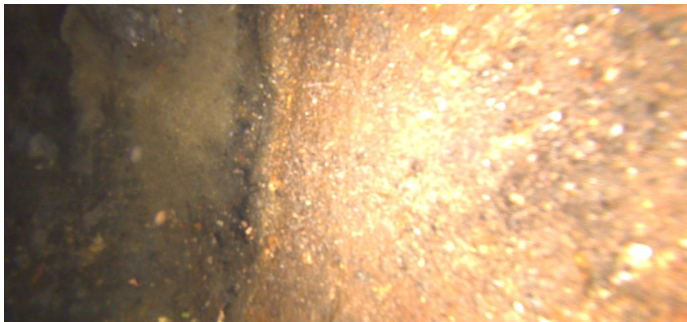
Code:	<b>MGO</b>
Description:	<b>General Observation</b>
Distance (ft):	<b>9.3</b>
Structural Grade:	<b>0</b>
O&M Grade:	<b>0</b>
Clock Start/From:	
Clock To:	
1st Value:	
2nd Value:	
Value Percent:	
Step:	<b>NO</b>
Remarks:	<b>END SURVEY</b>
