# Manhole Inspection Report

Date:	<b>05/08/2018</b>	Weather:		Coding:	<b>RZMACP</b>
MH#:	<b>M-1004-035</b>	Owner:	<b>NA</b>	Len. Surveyed:	<b>9.2</b>
P.O.#:		Surveyor:	<b>Jen Costello</b>	Rim to Invert:	<b>10.0</b>
Customer:		Cert. #:	<b>U-907-5518</b>	Wall Material:	<b>Concrete (reinforced)</b>

Street:	<b>Hillcrest Ave. 93' North of Home Av</b>	Project:	<b>Hobart, IN</b>
City:	<b>Hobart, IN</b>	GPS Northing:	<b>2912741.649</b>
Location:		GPS Easting:	<b>2912741.649</b>
Drain Area:	<b>Northeast</b>	GPS Accuracy:	<b>Sub-Meter</b>
Cover Shape:	<b>Circular</b>	Evidence of Surcharge:	<b>No</b>
Cover Size:	<b>22.5</b>	Potential for Runoff:	<b>None</b>
Comments:

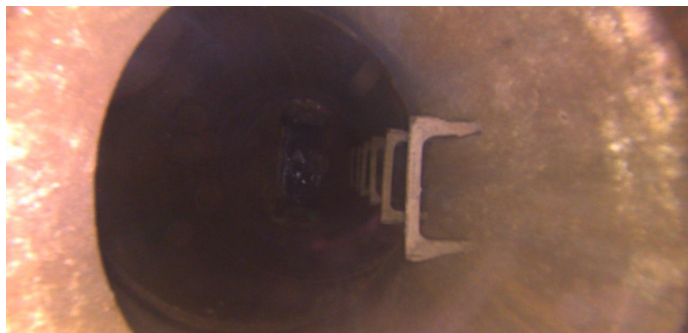
Code: **MGP**  
Description: **General Photo**

Distance (ft): **.0**  
Structural Grade: **0**  
O&M Grade: **0**  
Clock Start/From:  
Clock To:  
1st Value:  
2nd Value:  
Value Percent:  
Step: **NO**  
Remarks: **ACCESS MH**

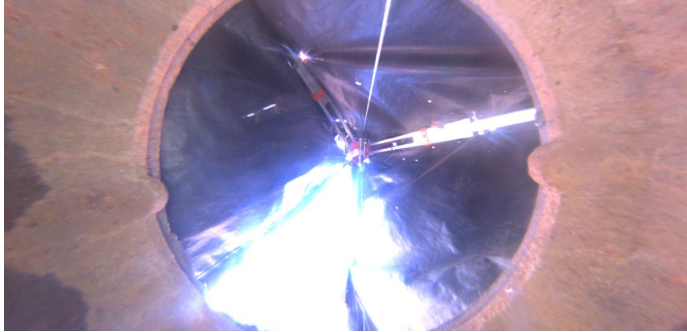
Code:	<b>MGO</b>
Description:	<b>General Observation</b>
Distance (ft):	<b>1.3</b>
Structural Grade:	<b>0</b>
O&M Grade:	<b>0</b>
Clock Start/From:	
Clock To:	
1st Value:	
2nd Value:	
Value Percent:	
Step:	<b>NO</b>
Remarks:	<b>UNDERSIDE OF FRAME</b>

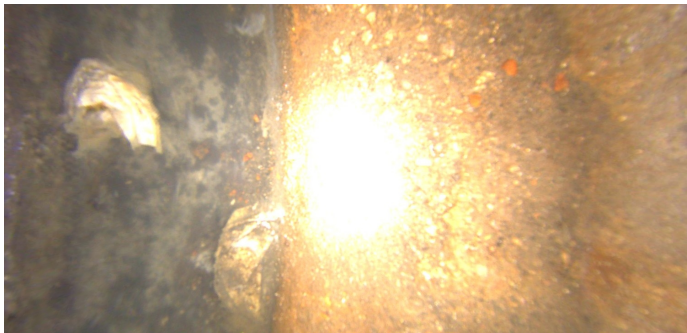
Code:	<b>MGO</b>
Description:	<b>General Observation</b>
Distance (ft):	<b>9.2</b>
Structural Grade:	<b>0</b>
O&M Grade:	<b>0</b>
Clock Start/From:	
Clock To:	
1st Value:	
2nd Value:	
Value Percent:	
Step:	<b>NO</b>
Remarks:	<b>END SURVEY</b>
