Manhole Inspection Report

Date:	05/11/2018	Weather:		Coding:	RZMACP
MH#:	M-1004-037	Owner:	NA	Len. Surveyed:	9.9
P.O.#:		Surveyor:	Jen Costello	Rim to Invert:	10.8
Customer:		Cert. #:	U-907-5518	Wall Material:	Concrete (reinforced)

Street:	Intersection of Hickey St. and Hillcre	Project:	Hobart, IN
City:	Hobart, IN	GPS Northing:	2912731.71
Location:		GPS Easting:	2912731.71
Drain Area:	Northeast	GPS Accuracy:	Sub-Meter
Cover Shape:	Circular	Evidence of Surcharge:	No
Cover Size:	22.5	Potential for Runoff:	None
Comments:

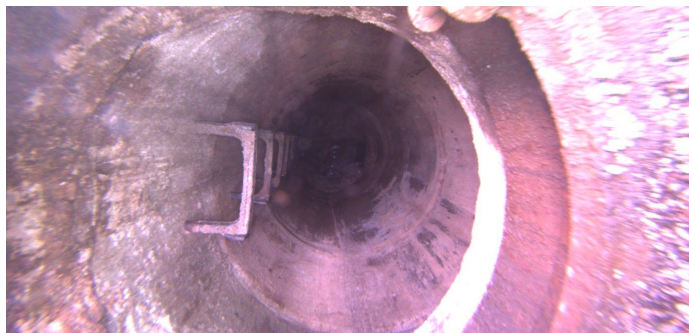
Code: **MGO**
Description: **General Observation**

Distance (ft): **.0**
Structural Grade: **0**
O&M Grade: **0**
Clock Start/From:
Clock To:
1st Value:
2nd Value:
Value Percent:
Step: **NO**
Remarks: **ACCESS MH**

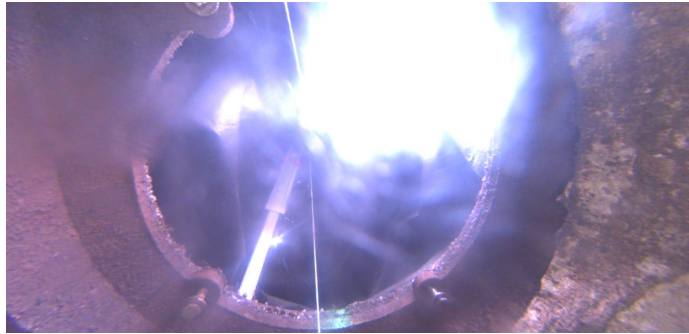
Code:	MGO
Description:	General Observation
Distance (ft):	1.8
Structural Grade:	0
O&M Grade:	0
Clock Start/From:	
Clock To:	
1st Value:	
2nd Value:	
Value Percent:	
Step:	NO
Remarks:	UNDERSIDE OF FRAME

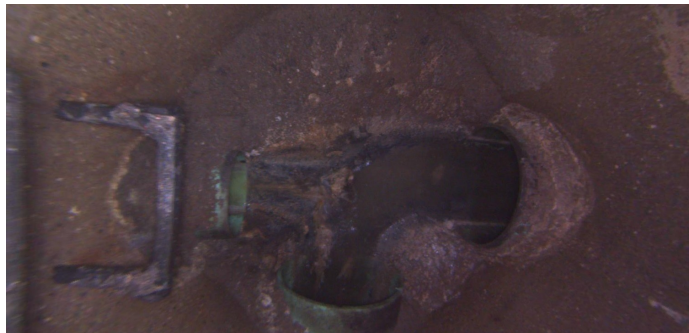
Code:	SAV
Description:	Surface Aggregate Visible
Distance (ft):	7.8
Structural Grade:	3
O&M Grade:	0
Clock Start/From:	12
Clock To:	12
1st Value:	
2nd Value:	
Value Percent:	
Step:	NO
Remarks:

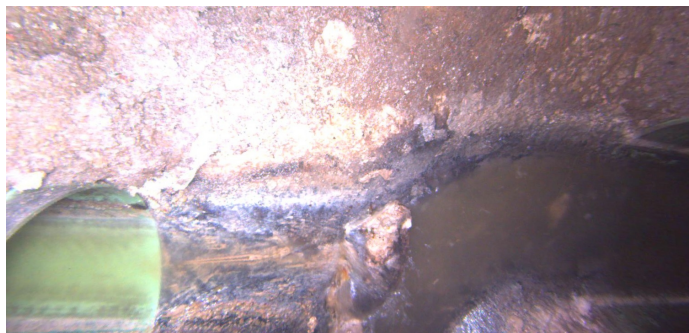
Code:	MGO
Description:	General Observation
Distance (ft):	9.9
Structural Grade:	0
O&M Grade:	0
Clock Start/From:	
Clock To:	
1st Value:	
2nd Value:	
Value Percent:	
Step:	NO
Remarks:	END SURVEY
