# Manhole Inspection Report

Date:	05/11/2018	Weather:		Coding:	RZMACP
MH#:	M-1004-038	Owner:	NA	Len. Surveyed:	9.9
P.O.#:		Surveyor:	Jen Costello	Rim to Invert:	9.8
Customer:		Cert. #:	U-907-5518	Wall Material:	Concrete (reinforced)

Street:	Coral Dr. 383' East of Hillcrest Ave.	Project:	Hobart, IN
City:	Hobart, IN	GPS Northing:	2913126.669
Location:		GPS Easting:	2913126.669
Drain Area:	Northeast	GPS Accuracy:	Sub-Meter
Cover Shape:	Circular	Evidence of Surcharge:	No
Cover Size:	22.5	Potential for Runoff:	None
Comments:

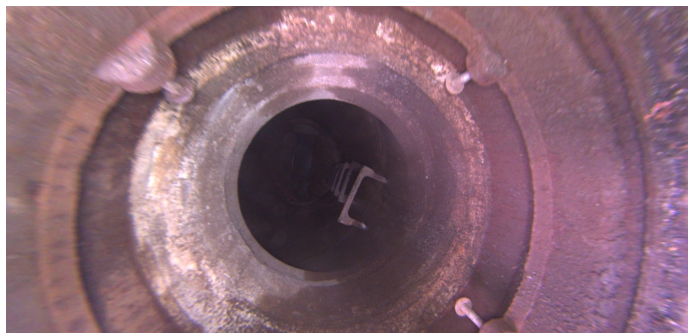
Code: **MGO**  
 Description: **General Observation**

Distance (ft): **.0**  
 Structural Grade: **0**  
 O&M Grade: **0**  
 Clock Start/From:  
 Clock To:  
 1st Value:  
 2nd Value:  
 Value Percent:  
 Step: **NO**  
 Remarks: **ACCESS MH**

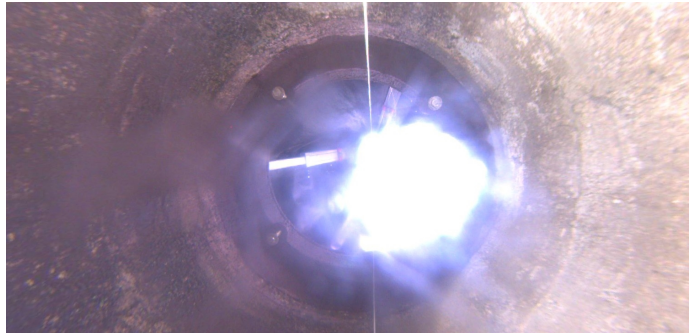
Code:	<b>MGO</b>
Description:	<b>General Observation</b>
Distance (ft):	<b>3.0</b>
Structural Grade:	<b>0</b>
O&M Grade:	<b>0</b>
Clock Start/From:	
Clock To:	
1st Value:	
2nd Value:	
Value Percent:	
Step:	<b>NO</b>
Remarks:	<b>UNDERSIDE OF FRAME</b>

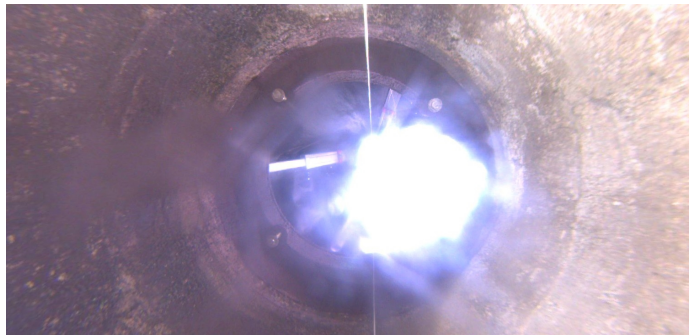
Code:	<b>SAV</b>
Description:	<b>Surface Aggregate Visible</b>
Distance (ft):	<b>3.0</b>
Structural Grade:	<b>3</b>
O&M Grade:	<b>0</b>
Clock Start/From:	<b>12</b>
Clock To:	<b>12</b>
1st Value:	
2nd Value:	
Value Percent:	
Step:	<b>NO</b>
Remarks:

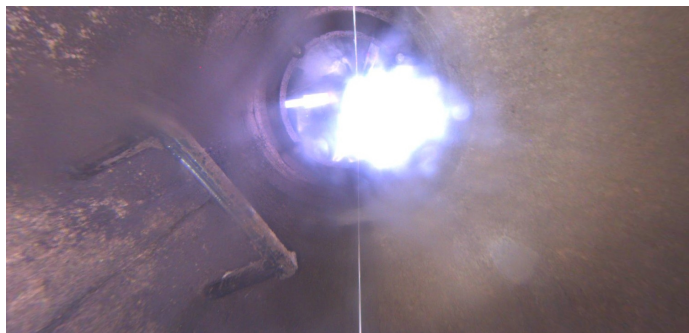
Code:	<b>FL</b>
Description:	<b>Fracture Longitudinal</b>
Distance (ft):	<b>4.2</b>
Structural Grade:	<b>3</b>
O&M Grade:	<b>0</b>
Clock Start/From:	<b>8</b>
Clock To:	
1st Value:	
2nd Value:	
Value Percent:	
Step:	<b>NO</b>
Remarks:

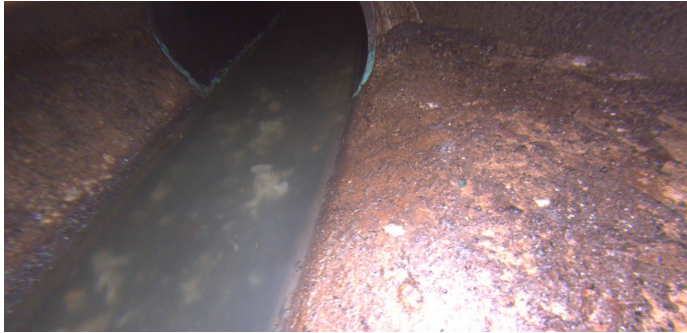
Code: **MGO**  
Description: **General Observation**

Distance (ft): **9.9**  
Structural Grade: **0**  
O&M Grade: **0**  
Clock Start/From:  
Clock To:  
1st Value:  
2nd Value:  
Value Percent:  
Step: **NO**  
Remarks: **END SURVEY**
