Manhole Inspection Report

Date:	05/11/2018	Weather:		Coding:	RZMACP
MH#:	M-1004-044	Owner:	NA	Len. Surveyed:	5.2
P.O.#:		Surveyor:	Jen Costello	Rim to Invert:	5.3
Customer:		Cert. #:	U-907-5518	Wall Material:	Concrete (reinforced)

Street:	Ryan Ct. at the North End.	Project:	Hobart, IN
City:	Hobart, IN	GPS Northing:	2914835.508
Location:		GPS Easting:	2914835.508
Drain Area:	Northeast	GPS Accuracy:	Sub-Meter
Cover Shape:	Circular	Evidence of Surcharge:	No
Cover Size:	22.5	Potential for Runoff:	None
Comments:

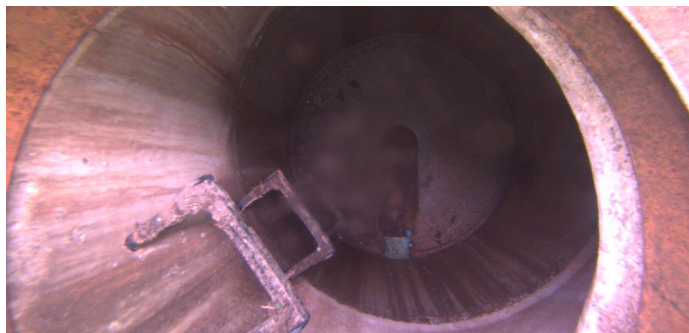
Code: **MGO**
Description: **General Observation**

Distance (ft): **.0**
Structural Grade: **0**
O&M Grade: **0**
Clock Start/From:
Clock To:
1st Value:
2nd Value:
Value Percent:
Step: **NO**
Remarks: **ACCESS MH**

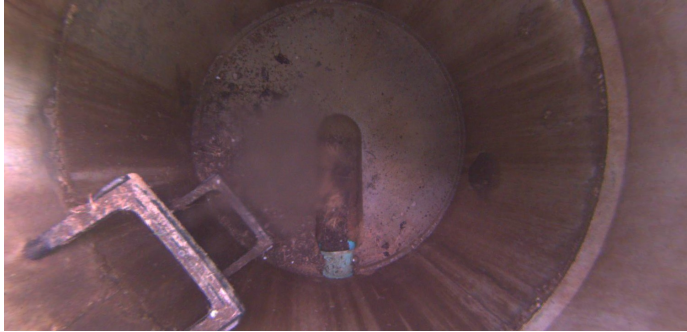
Code: **IS**
Description: **Infil Stain**

Distance (ft): **1.1**
Structural Grade: **0**
O&M Grade: **0**
Clock Start/From: **12**
Clock To: **12**
1st Value:
2nd Value:
Value Percent:
Step: **NO**
Remarks:

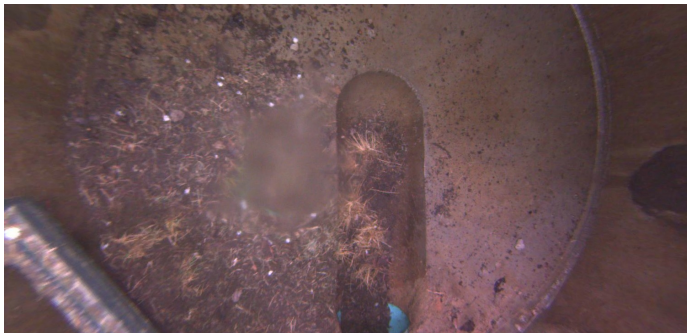
Code: **DSF**
Description: **Deposits Settled Fine**

Distance (ft): **3.2**
Structural Grade: **0**
O&M Grade: **2**
Clock Start/From: **12**
Clock To: **12**
1st Value:
2nd Value:
Value Percent: **5.000**
Step: **NO**
Remarks:

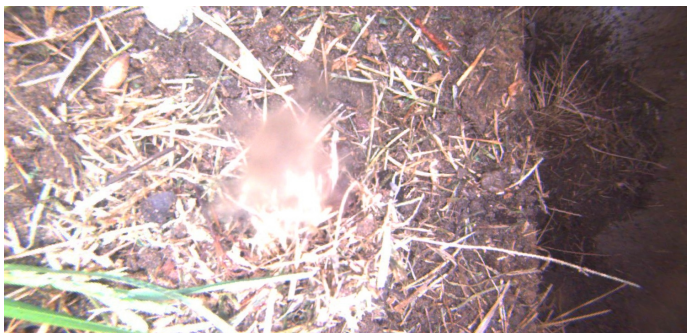
Code: **DSF**
Description: **Deposits Settled Fine**

Distance (ft): **5.2**
Structural Grade: **0**
O&M Grade: **2**
Clock Start/From: **5**
Clock To: **7**
1st Value:
2nd Value:
Value Percent: **10.000**
Step: **NO**
Remarks:

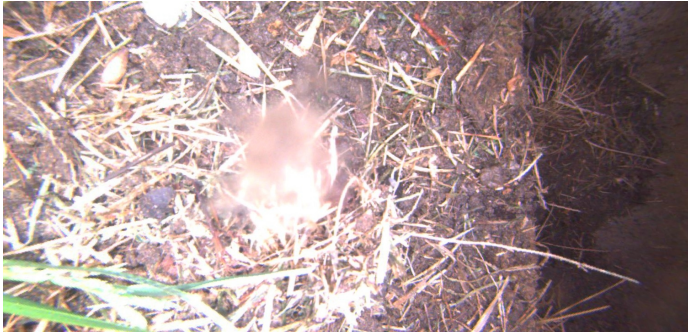
Code:	MGO
Description:	General Observation
Distance (ft):	5.2
Structural Grade:	0
O&M Grade:	0
Clock Start/From:	
Clock To:	
1st Value:	
2nd Value:	
Value Percent:	
Step:	NO
Remarks:	END SURVEY
