Manhole Inspection Report

Date:	05/11/2018	Weather:		Coding:	RZMACP
MH#:	M-1004-051	Owner:	NA	Len. Surveyed:	5.6
P.O.#:		Surveyor:	Jen Costello	Rim to Invert:	6.2
Customer:		Cert. #:	U-907-5518	Wall Material:	Concrete (reinforced)

Street:	Intersection of Barberry Dr. and Ha	Project:	Hobart, IN
City:	Hobart, IN	GPS Northing:	2914229.721
Location:		GPS Easting:	2914229.721
Drain Area:	Northeast	GPS Accuracy:	Sub-Meter
Cover Shape:	Circular	Evidence of Surcharge:	No
Cover Size:	22.5	Potential for Runoff:	None
Comments:

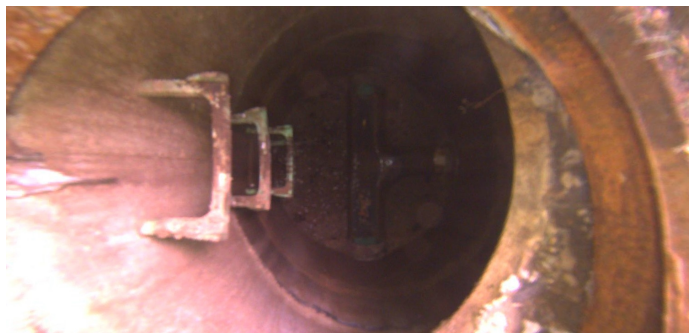
Code: **MGP**
Description: **General Photo**

Distance (ft): **.0**
Structural Grade: **0**
O&M Grade: **0**
Clock Start/From:
Clock To:
1st Value:
2nd Value:
Value Percent:
Step: **NO**
Remarks: **ACCESS MH**

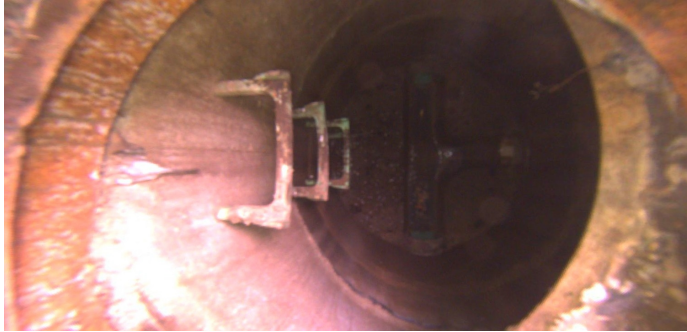
Code: **RFJ**
Description: **Roots Fine Joint**

Distance (ft): **.0**
Structural Grade: **0**
O&M Grade: **1**
Clock Start/From: **9**
Clock To:
1st Value:
2nd Value:
Value Percent:
Step: **NO**
Remarks:

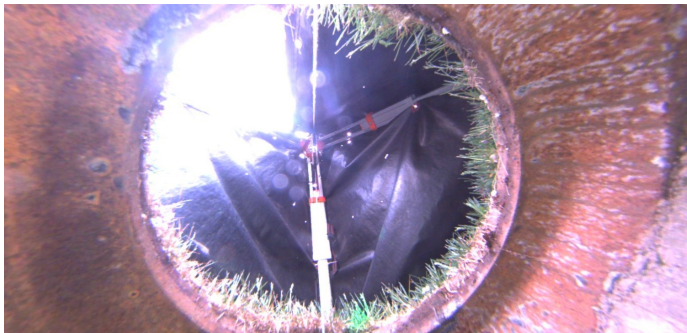
Code: **MGO**
Description: **General Observation**

Distance (ft): **1.6**
Structural Grade: **0**
O&M Grade: **0**
Clock Start/From:
Clock To:
1st Value:
2nd Value:
Value Percent:
Step: **NO**
Remarks: **UNDERSIDE OF FRAME**

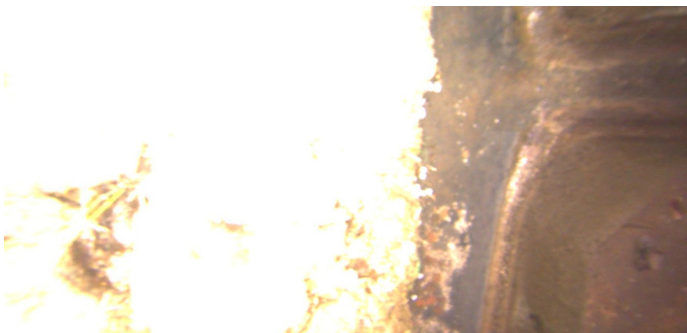
Code: **MGO**
Description: **General Observation**

Distance (ft): **5.6**
Structural Grade: **0**
O&M Grade: **0**
Clock Start/From:
Clock To:
1st Value:
2nd Value:
Value Percent:
Step: **NO**
Remarks: **END SURVEY**
