Manhole Inspection Report

Date:	05/11/2018	Weather:		Coding:	RZMACP
MH#:	M-1004-053	Owner:	NA	Len. Surveyed:	5.9
P.O.#:		Surveyor:	Jen Costello	Rim to Invert:	6.0
Customer:		Cert. #:	U-907-5518	Wall Material:	Concrete (reinforced)

Street:	Hemlock Ct.	Project:	Hobart, IN
City:	Hobart, IN	GPS Northing:	2913909.024
Location:		GPS Easting:	2913909.024
Drain Area:	Northeast	GPS Accuracy:	Sub-Meter
Cover Shape:	Circular	Evidence of Surcharge:	No
Cover Size:	22.5	Potential for Runoff:	None
Comments:

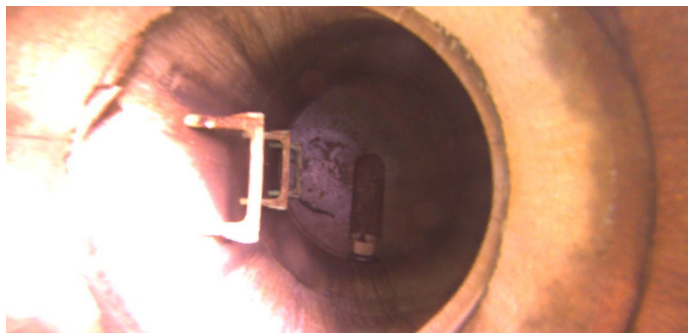
Code: **MGO**
Description: **General Observation**

Distance (ft): **.0**
Structural Grade: **0**
O&M Grade: **0**
Clock Start/From:
Clock To:
1st Value:
2nd Value:
Value Percent:
Step: **NO**
Remarks: **ACCESS MH**

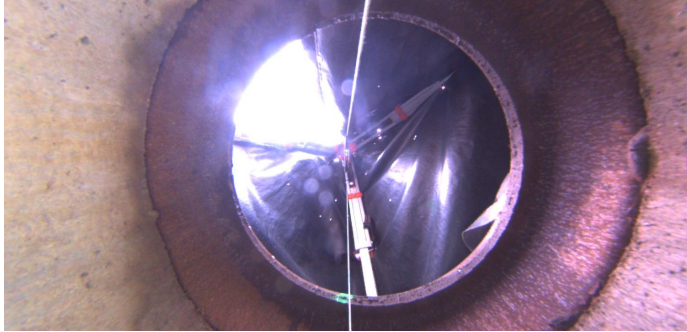
Code:	MGO
Description:	General Observation
Distance (ft):	1.7
Structural Grade:	0
O&M Grade:	0
Clock Start/From:	
Clock To:	
1st Value:	
2nd Value:	
Value Percent:	
Step:	NO
Remarks:	UNDERSIDE OF FRAME

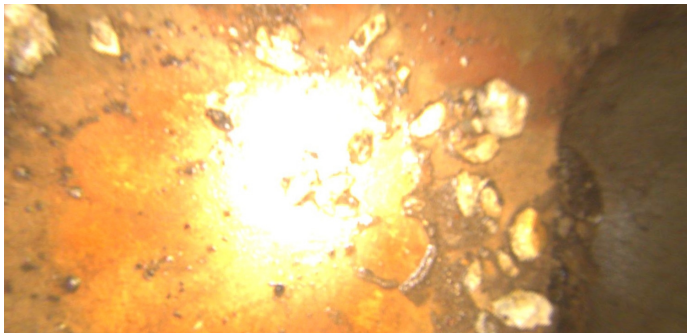
Code:	MGO
Description:	General Observation
Distance (ft):	5.8
Structural Grade:	0
O&M Grade:	0
Clock Start/From:	
Clock To:	
1st Value:	
2nd Value:	
Value Percent:	
Step:	NO
Remarks:	END SURVEY
