Manhole Inspection Report

Date:	05/11/2018	Weather:		Coding:	RZMACP
MH#:	M-1004-054	Owner:	NA	Len. Surveyed:	6.1
P.O.#:		Surveyor:	Jen Costello	Rim to Invert:	7.1
Customer:		Cert. #:	U-907-5518	Wall Material:	Concrete (reinforced)

Street:	Barberry Dr. 179' West of Hemlock C	Project:	Hobart, IN
City:	Hobart, IN	GPS Northing:	2913709.295
Location:		GPS Easting:	2913709.295
Drain Area:	Northeast	GPS Accuracy:	Sub-Meter
Cover Shape:	Circular	Evidence of Surcharge:	No
Cover Size:	22.5	Potential for Runoff:	None
Comments:

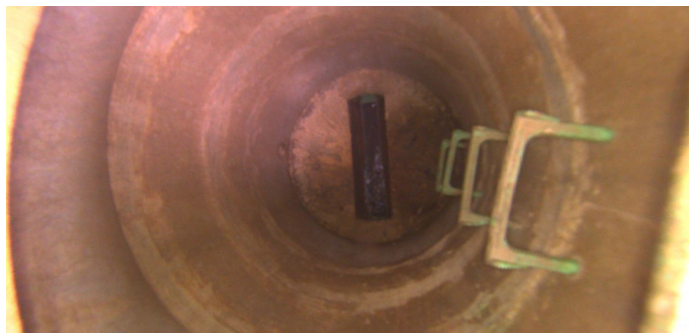
Code:	MGP
Description:	General Photo
Distance (ft):	.0
Structural Grade:	0
O&M Grade:	0
Clock Start/From:	
Clock To:	
1st Value:	
2nd Value:	
Value Percent:	
Step:	NO
Remarks:	ACCESS MH

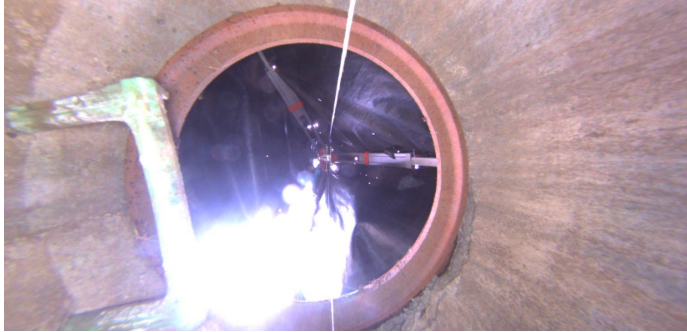
Code:	MGO
Description:	General Observation
Distance (ft):	1.6
Structural Grade:	0
O&M Grade:	0
Clock Start/From:	
Clock To:	
1st Value:	
2nd Value:	
Value Percent:	
Step:	NO
Remarks:	UNDERSIDE OF FRAME

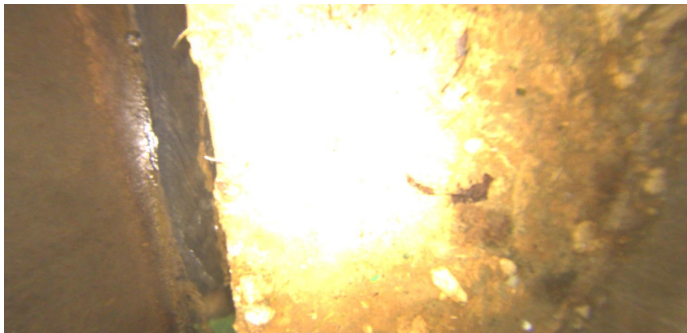
Code:	MGO
Description:	General Observation
Distance (ft):	6.1
Structural Grade:	0
O&M Grade:	0
Clock Start/From:	
Clock To:	
1st Value:	
2nd Value:	
Value Percent:	
Step:	NO
Remarks:	END SURVEY
