Manhole Inspection Report

Date:	05/11/2018	Weather:		Coding:	RZMACP
MH#:	M-1004-059	Owner:	NA	Len. Surveyed:	7.9
P.O.#:		Surveyor:	Jen Costello	Rim to Invert:	8.3
Customer:		Cert. #:	U-907-5518	Wall Material:	Concrete (reinforced)

Street:	Barberry Dr. 129' East of Hillcrest Av	Project:	Hobart, IN
City:	Hobart, IN	GPS Northing:	2912991.657
Location:		GPS Easting:	2912991.657
Drain Area:	Northeast	GPS Accuracy:	Sub-Meter
Cover Shape:	Circular	Evidence of Surcharge:	No
Cover Size:	22.5	Potential for Runoff:	None
Comments:

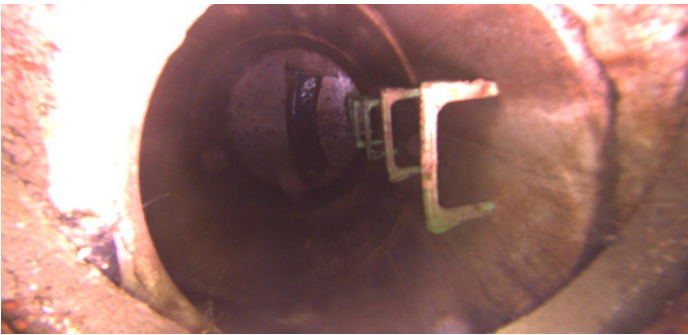
Code:	MGP
Description:	General Photo
Distance (ft):	.0
Structural Grade:	0
O&M Grade:	0
Clock Start/From:	
Clock To:	
1st Value:	
2nd Value:	
Value Percent:	
Step:	NO
Remarks:	ACCESS MH

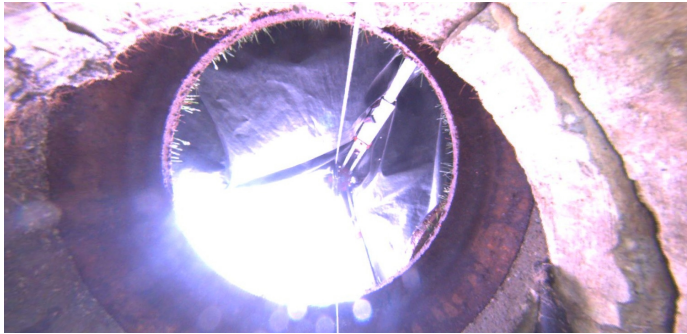
Code: **B**
Description: **Broken**

Distance (ft): **1.7**
Structural Grade: **5**
O&M Grade: **0**
Clock Start/From: **9**
Clock To: **3**
1st Value:
2nd Value:
Value Percent:
Step: **NO**
Remarks:

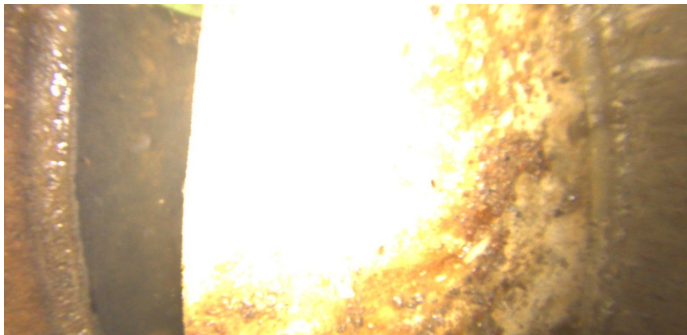
Code: **MGO**
Description: **General Observation**

Distance (ft): **7.9**
Structural Grade: **0**
O&M Grade: **0**
Clock Start/From:
Clock To:
1st Value:
2nd Value:
Value Percent:
Step: **NO**
Remarks: **END SURVEY**
