Manhole Inspection Report

Date:	05/11/2018	Weather:		Coding:	RZMACP
MH#:	M-1004-060	Owner:	NA	Len. Surveyed:	8.1
P.O.#:		Surveyor:	Jen Costello	Rim to Invert:	8.8
Customer:		Cert. #:	U-907-5518	Wall Material:	Concrete (reinforced)

Street:	Intersection of Hillcrest Ave. and Ba	Project:	Hobart, IN
City:	Hobart, IN	GPS Northing:	2912838.769
Location:		GPS Easting:	2912838.769
Drain Area:	Northeast	GPS Accuracy:	Sub-Meter
Cover Shape:	Circular	Evidence of Surcharge:	No
Cover Size:	22.5	Potential for Runoff:	None
Comments:

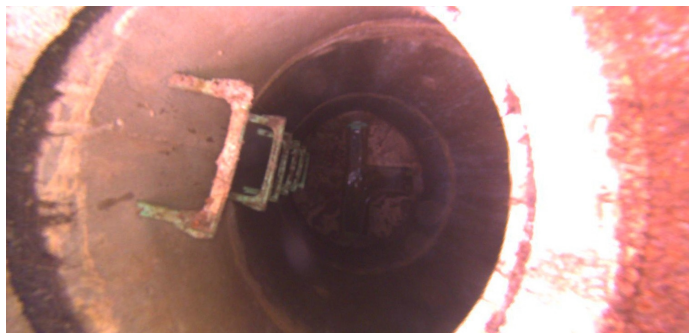
Code: **MGP**
Description: **General Photo**

Distance (ft): **.0**
Structural Grade: **0**
O&M Grade: **0**
Clock Start/From:
Clock To:
1st Value:
2nd Value:
Value Percent:
Step: **NO**
Remarks: **ACCESS MH**

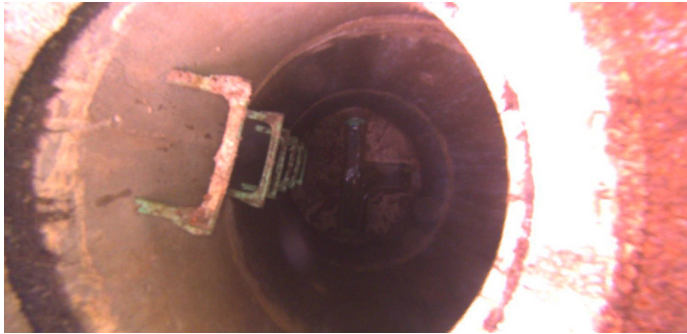
Code: **RFJ**
Description: **Roots Fine Joint**

Distance (ft): **.0**
Structural Grade: **0**
O&M Grade: **1**
Clock Start/From: **8**
Clock To: **10**
1st Value:
2nd Value:
Value Percent:
Step: **NO**
Remarks:

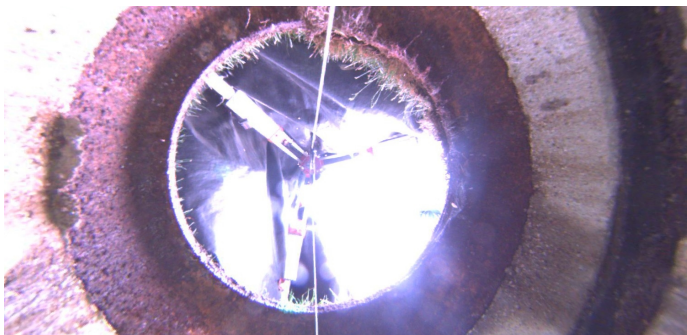
Code: **MGO**
Description: **General Observation**

Distance (ft): **1.8**
Structural Grade: **0**
O&M Grade: **0**
Clock Start/From:
Clock To:
1st Value:
2nd Value:
Value Percent:
Step: **NO**
Remarks: **UNDERSIDE OF FRAME**

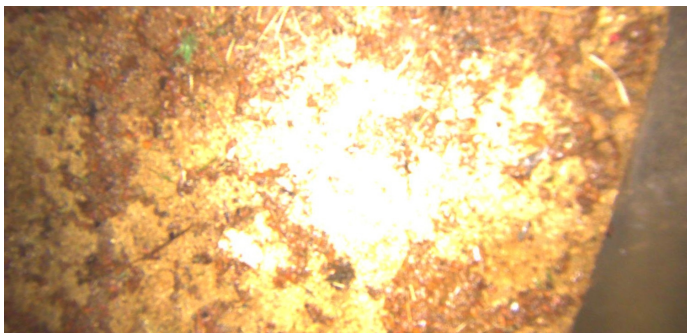
Code: **MGO**
Description: **General Observation**

Distance (ft): **8.1**
Structural Grade: **0**
O&M Grade: **0**
Clock Start/From:
Clock To:
1st Value:
2nd Value:
Value Percent:
Step: **NO**
Remarks: **END SURVEY**
