Manhole Inspection Report

Date:	05/11/2018	Weather:		Coding:	RZMACP
MH#:	M-1004-062	Owner:	NA	Len. Surveyed:	9.2
P.O.#:		Surveyor:	Jen Costello	Rim to Invert:	9.4
Customer:		Cert. #:	U-907-5518	Wall Material:	Concrete (reinforced)

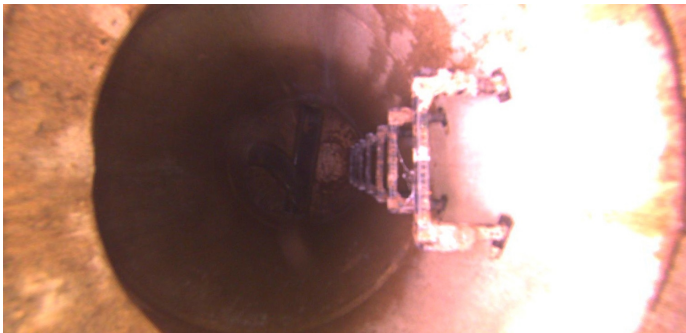
Code:	MGP
Description:	General Photo

Distance (ft):	.0
Structural Grade:	0
O&M Grade:	0
Clock Start/From:	
Clock To:	
1st Value:	
2nd Value:	
Value Percent:	
Step:	NO
Remarks:	AC

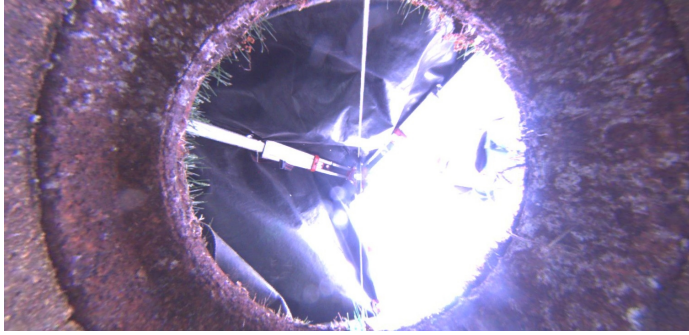
Code: **MGO**
Description: **General Observation**

Distance (ft): **1.2**
Structural Grade: **0**
O&M Grade: **0**
Clock Start/From:
Clock To:
1st Value:
2nd Value:
Value Percent:
Step: **NO**
Remarks: **UNDERSIDE OF FRAME**
