Manhole Inspection Report

Date:	05/11/2018	Weather:		Coding:	RZMACP
MH#:	M-1004-063	Owner:	NA	Len. Surveyed:	8.5
P.O.#:		Surveyor:	Jen Costello	Rim to Invert:	9.1
Customer:		Cert. #:	U-907-5518	Wall Material:	Concrete (reinforced)

Street:	Hillcrest Ave. 132' North of Hickey S	Project:	Hobart, IN
City:	Hobart, IN	GPS Northing:	2912721.37
Location:		GPS Easting:	2912721.37
Drain Area:	Northeast	GPS Accuracy:	Sub-Meter
Cover Shape:	Circular	Evidence of Surcharge:	No
Cover Size:	22.5	Potential for Runoff:	None
Comments:

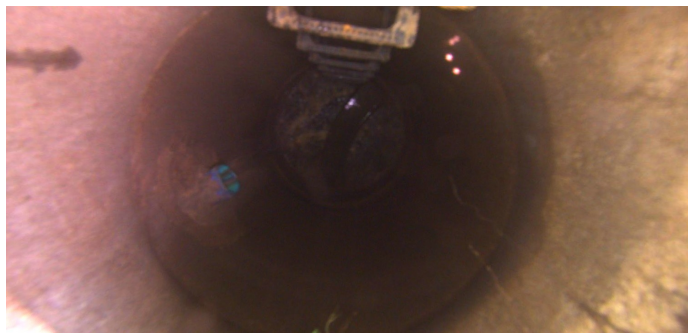
Code: **MGP**
Description: **General Photo**

Distance (ft): **.0**
Structural Grade: **0**
O&M Grade: **0**
Clock Start/From:
Clock To:
1st Value:
2nd Value:
Value Percent:
Step: **NO**
Remarks: **ACCESS MH**

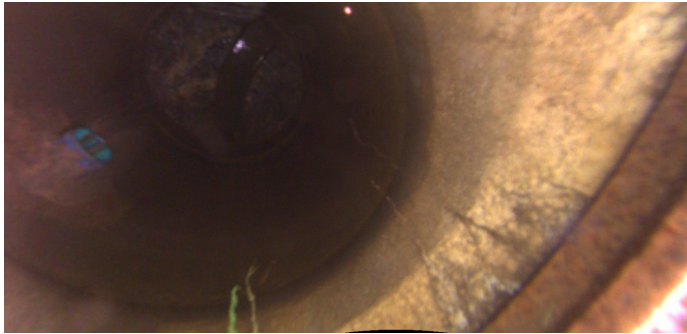
Code: **RFJ**
Description: **Roots Fine Joint**

Distance (ft): **.0**
Structural Grade: **0**
O&M Grade: **1**
Clock Start/From: **3**
Clock To: **6**
1st Value:
2nd Value:
Value Percent:
Step: **NO**
Remarks:

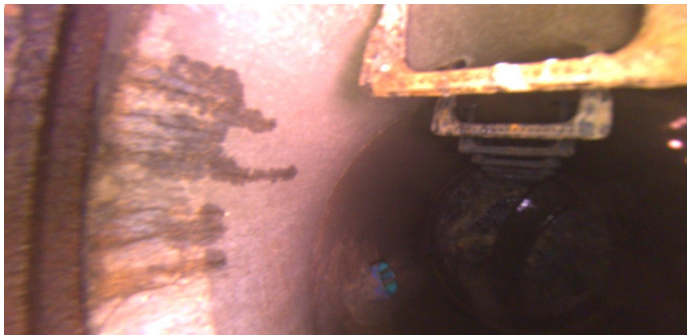
Code: **IW**
Description: **Infil Weeper**

Distance (ft): **.0**
Structural Grade: **0**
O&M Grade: **2**
Clock Start/From: **8**
Clock To: **9**
1st Value:
2nd Value:
Value Percent:
Step: **NO**
Remarks:

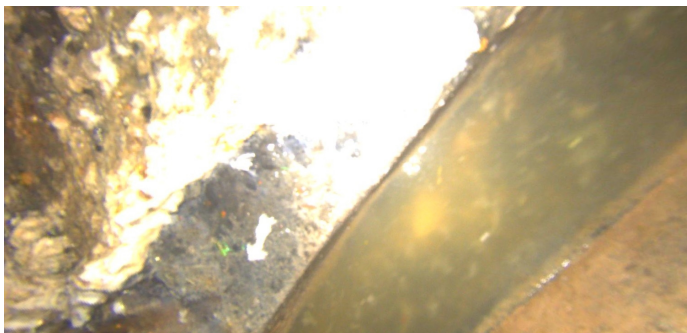
Code: **MGO**
Description: **General Observation**

Distance (ft): **8.5**
Structural Grade: **0**
O&M Grade: **0**
Clock Start/From:
Clock To:
1st Value:
2nd Value:
Value Percent:
Step: **NO**
Remarks: **END SURVEY**
