Manhole Inspection Report

Date:	05/11/2018	Weather:		Coding:	RZMACP
MH#:	M-1004-064	Owner:	NA	Len. Surveyed:	8.9
P.O.#:		Surveyor:	Jen Costello	Rim to Invert:	9.7
Customer:		Cert. #:	U-907-5518	Wall Material:	Concrete (reinforced)

Street:	Poplar Ln. 259' West of Hillcrest Ave.	Project:	Hobart, IN
City:	Hobart, IN	GPS Northing:	2912545.887
Location:		GPS Easting:	2912545.887
Drain Area:	Northeast	GPS Accuracy:	Sub-Meter
Cover Shape:	Circular	Evidence of Surcharge:	No
Cover Size:	22.5	Potential for Runoff:	None
Comments:

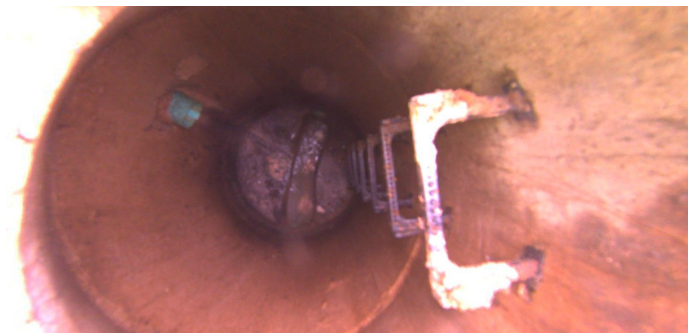
Code: **MGP**
 Description: **General Photo**

Distance (ft): **.0**
 Structural Grade: **0**
 O&M Grade: **0**
 Clock Start/From:
 Clock To:
 1st Value:
 2nd Value:
 Value Percent:
 Step: **NO**
 Remarks: **ACCESS MH**

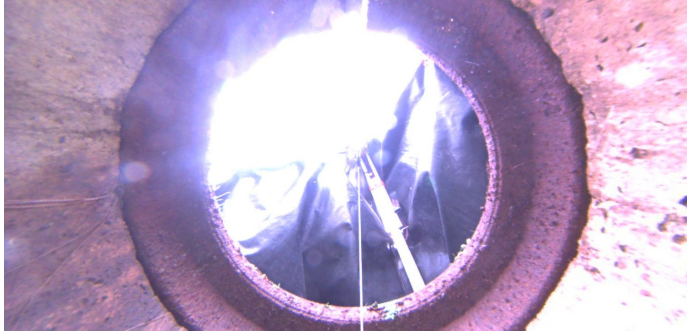
Code: **MGO**
Description: **General Observation**

Distance (ft): **1.6**
Structural Grade: **0**
O&M Grade: **0**
Clock Start/From:
Clock To:
1st Value:
2nd Value:
Value Percent:
Step: **NO**
Remarks: **UNDERSIDE OF FRAME**

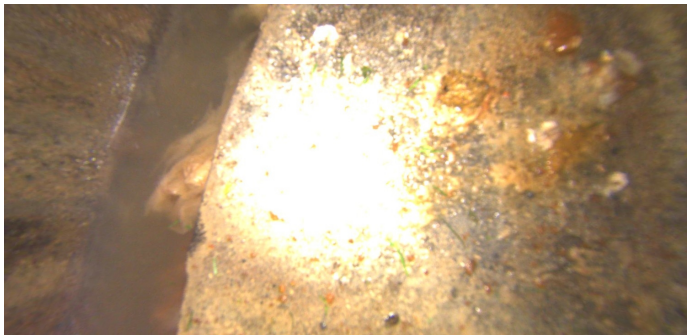
Code: **MGO**
Description: **General Observation**

Distance (ft): **8.9**
Structural Grade: **0**
O&M Grade: **0**
Clock Start/From:
Clock To:
1st Value:
2nd Value:
Value Percent:
Step: **NO**
Remarks: **END SURVEY**
