Manhole Inspection Report

Date:	05/11/2018	Weather:		Coding:	RZMACP
MH#:	M-1004-065	Owner:	NA	Len. Surveyed:	6.6
P.O.#:		Surveyor:	Jen Costello	Rim to Invert:	6.9
Customer:		Cert. #:	U-907-5518	Wall Material:	Concrete (reinforced)

Street:	Poplar Ln. 159' North of Linden Ave.	Project:	Hobart, IN
City:	Hobart, IN	GPS Northing:	2912581.582
Location:		GPS Easting:	2912581.582
Drain Area:	Northeast	GPS Accuracy:	Sub-Meter
Cover Shape:	Circular	Evidence of Surcharge:	No
Cover Size:	22.5	Potential for Runoff:	None
Comments:

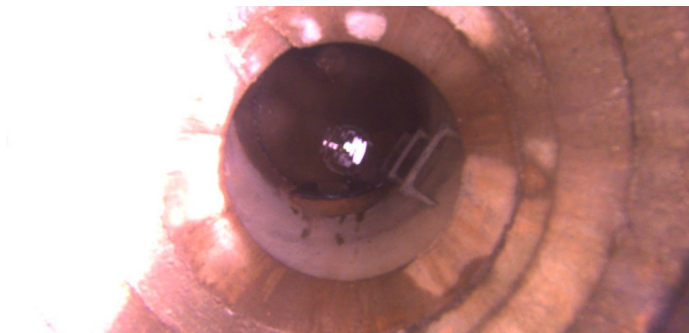
Code: **MGP**
Description: **General Photo**

Distance (ft): **.0**
Structural Grade: **0**
O&M Grade: **0**
Clock Start/From:
Clock To:
1st Value:
2nd Value:
Value Percent:
Step: **NO**
Remarks: **access mh**

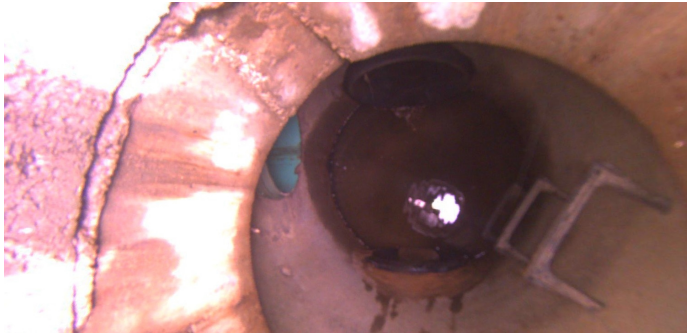
Code: **FM**
Description: **Fracture Multiple**

Distance (ft): **.9**
Structural Grade: **4**
O&M Grade: **0**
Clock Start/From: **8**
Clock To: **10**
1st Value:
2nd Value:
Value Percent:
Step: **NO**
Remarks:

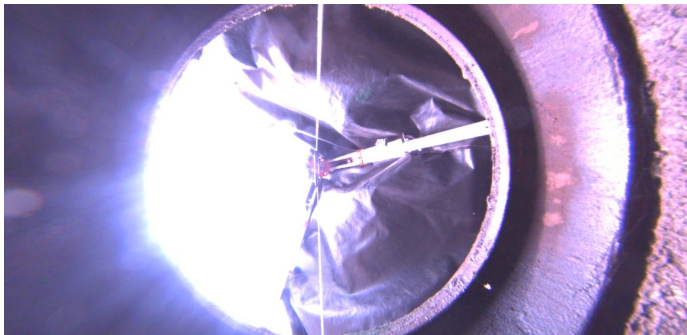
Code: **MGO**
Description: **General Observation**

Distance (ft): **1.3**
Structural Grade: **0**
O&M Grade: **0**
Clock Start/From:
Clock To:
1st Value:
2nd Value:
Value Percent:
Step: **NO**
Remarks: **underside of frame**

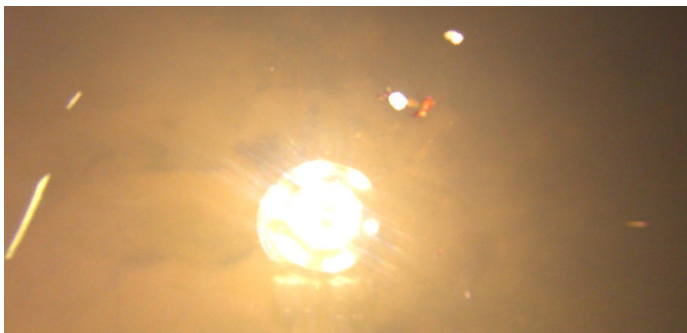
Code: **MGO**
Description: **General Observation**

Distance (ft): **6.6**
Structural Grade: **0**
O&M Grade: **0**
Clock Start/From:
Clock To:
1st Value:
2nd Value:
Value Percent:
Step: **NO**
Remarks: **end survey**
