Manhole Inspection Report

Date:	05/11/2018	Weather:		Coding:	RZMACP
MH#:	M-1004-066	Owner:	NA	Len. Surveyed:	8.5
P.O.#:		Surveyor:	Jen Costello	Rim to Invert:	9.1
Customer:		Cert. #:	U-907-5518	Wall Material:	Concrete (reinforced)

Street:	Poplar Ln. 170' East of Union St.	Project:	Hobart, IN
City:	Hobart, IN	GPS Northing:	2912540.852
Location:		GPS Easting:	2912540.852
Drain Area:	Northeast	GPS Accuracy:	Sub-Meter
Cover Shape:	Circular	Evidence of Surcharge:	No
Cover Size:	22.5	Potential for Runoff:	None
Comments:

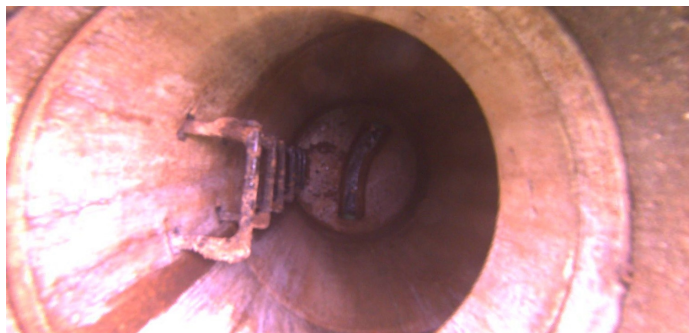
Code:	MGP
Description:	General Photo
Distance (ft):	.0
Structural Grade:	0
O&M Grade:	0
Clock Start/From:	
Clock To:	
1st Value:	
2nd Value:	
Value Percent:	
Step:	NO
Remarks:	ACCESS MH

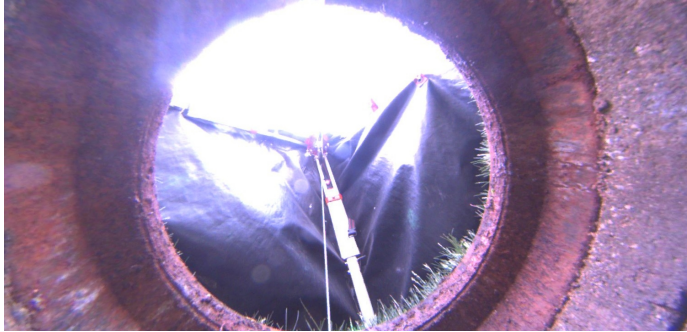
Code: **MGO**
Description: **General Observation**

Distance (ft): **1.2**
Structural Grade: **0**
O&M Grade: **0**
Clock Start/From:
Clock To:
1st Value:
2nd Value:
Value Percent:
Step: **NO**
Remarks: **UNDERSIDE OF FRAME**

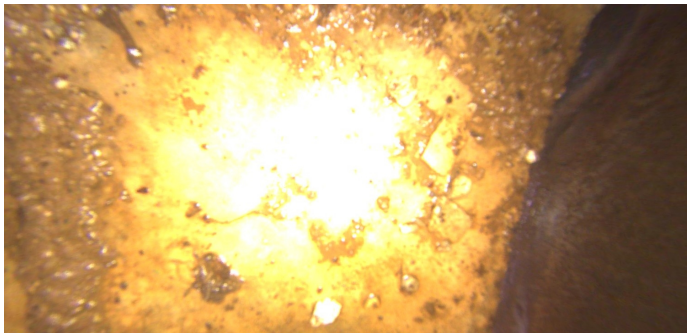
Code: **MGO**
Description: **General Observation**

Distance (ft): **8.5**
Structural Grade: **0**
O&M Grade: **0**
Clock Start/From:
Clock To:
1st Value:
2nd Value:
Value Percent:
Step: **NO**
Remarks: **END SURVEY**
