# Manhole Inspection Report

Date:	05/11/2018	Weather:		Coding:	RZMACP
MH#:	M-1004-068	Owner:	NA	Len. Surveyed:	6.7
P.O.#:		Surveyor:	Jen Costello	Rim to Invert:	7.4
Customer:		Cert. #:	U-907-5518	Wall Material:	Concrete (reinforced)

Street:	Tulip Ln. 280' East of Union St.	Project:	Hobart, IN
City:	Hobart, IN	GPS Northing:	2912638.491
Location:		GPS Easting:	2912638.491
Drain Area:	Northeast	GPS Accuracy:	Sub-Meter
Cover Shape:	Circular	Evidence of Surcharge:	No
Cover Size:	22.5	Potential for Runoff:	None
Comments:

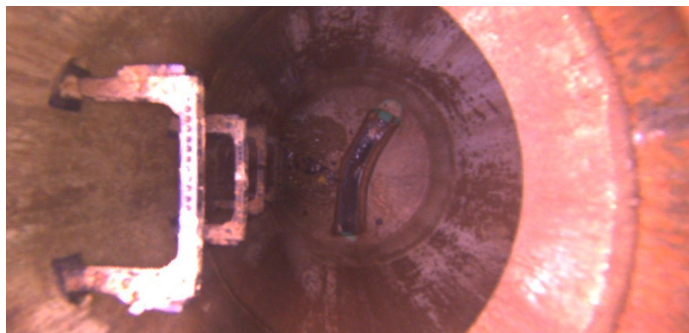
Code: **MGP**  
Description: **General Photo**

Distance (ft): **.0**  
Structural Grade: **0**  
O&M Grade: **0**  
Clock Start/From:  
Clock To:  
1st Value:  
2nd Value:  
Value Percent:  
Step: **NO**  
Remarks: **access MH**

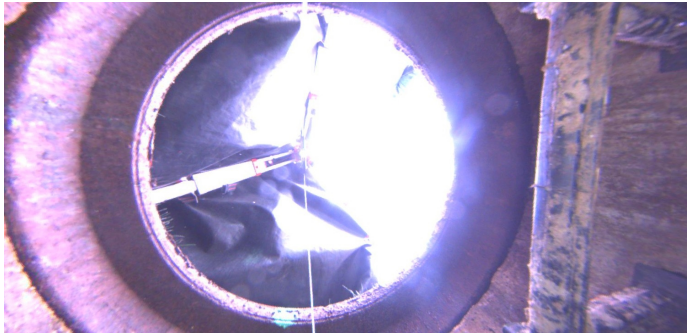
Code: **MGO**  
Description: **General Observation**

Distance (ft): **1.7**  
Structural Grade: **0**  
O&M Grade: **0**  
Clock Start/From:  
Clock To:  
1st Value:  
2nd Value:  
Value Percent:  
Step: **NO**  
Remarks: **UNDERSIDE OF FRAME**

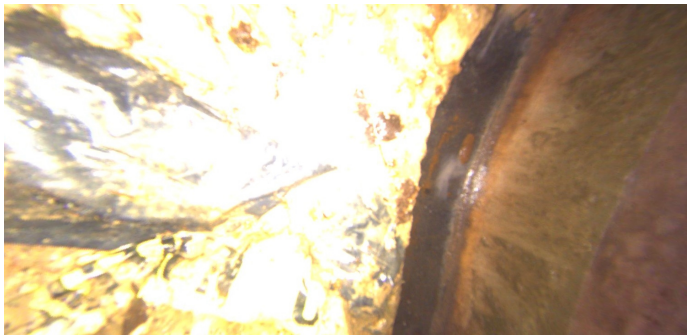
Code: **MGO**  
Description: **General Observation**

Distance (ft): **6.7**  
Structural Grade: **0**  
O&M Grade: **0**  
Clock Start/From:  
Clock To:  
1st Value:  
2nd Value:  
Value Percent:  
Step: **NO**  
Remarks: **END SURVEY**
