# Manhole Inspection Report

Date:	<b>05/11/2018</b>	Weather:		Coding:	<b>RZMACP</b>
MH#:	<b>M-1004-069</b>	Owner:	<b>NA</b>	Len. Surveyed:	<b>6.6</b>
P.O.#:		Surveyor:	<b>Jen Costello</b>	Rim to Invert:	<b>6.7</b>
Customer:		Cert. #:	<b>U-907-5518</b>	Wall Material:	<b>Concrete (reinforced)</b>

Street:	<b>Tulip Ln. 388' East of Union St.</b>	Project:	<b>Hobart, IN</b>
City:	<b>Hobart, IN</b>	GPS Northing:	<b>2912739.816</b>
Location:		GPS Easting:	<b>2912739.816</b>
Drain Area:	<b>Northeast</b>	GPS Accuracy:	<b>Sub-Meter</b>
Cover Shape:	<b>Circular</b>	Evidence of Surcharge:	<b>No</b>
Cover Size:	<b>22.5</b>	Potential for Runoff:	<b>None</b>
Comments:

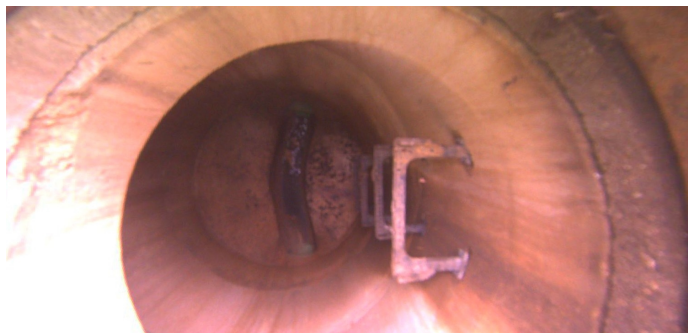
Code: **MGP**  
Description: **General Photo**

Distance (ft): **.0**  
Structural Grade: **0**  
O&M Grade: **0**  
Clock Start/From:  
Clock To:  
1st Value:  
2nd Value:  
Value Percent:  
Step: **NO**  
Remarks: **ACCESS MH**

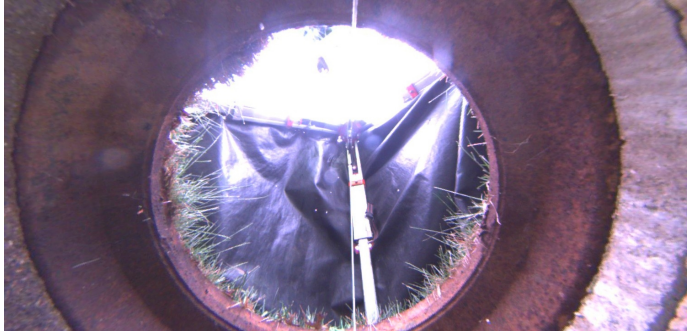
Code:	<b>MGO</b>
Description:	<b>General Observation</b>
Distance (ft):	<b>1.3</b>
Structural Grade:	<b>0</b>
O&M Grade:	<b>0</b>
Clock Start/From:	
Clock To:	
1st Value:	
2nd Value:	
Value Percent:	
Step:	<b>NO</b>
Remarks:	<b>UNDERSIDE OF FRAME</b>
