# Manhole Inspection Report

Date:	<b>05/11/2018</b>	Weather:		Coding:	<b>RZMACP</b>
MH#:	<b>M-1004-071</b>	Owner:	<b>NA</b>	Len. Surveyed:	<b>5.4</b>
P.O.#:		Surveyor:	<b>Jen Costello</b>	Rim to Invert:	<b>6.0</b>
Customer:		Cert. #:	<b>U-907-5518</b>	Wall Material:	<b>Concrete (reinforced)</b>

Street:	<b>Tulip Ln. 1013' East of Union St.</b>	Project:	<b>Hobart, IN</b>
City:	<b>Hobart, IN</b>	GPS Northing:	<b>2913352.92</b>
Location:		GPS Easting:	<b>2913352.92</b>
Drain Area:	<b>Northeast</b>	GPS Accuracy:	<b>Sub-Meter</b>
Cover Shape:	<b>Circular</b>	Evidence of Surcharge:	<b>No</b>
Cover Size:	<b>22.5</b>	Potential for Runoff:	<b>None</b>
Comments:

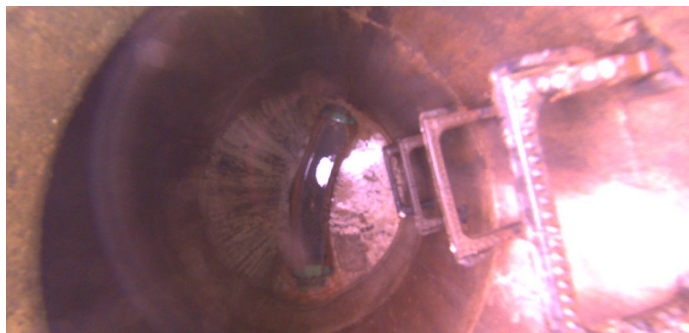
Code:	<b>MGP</b>
Description:	<b>General Photo</b>
Distance (ft):	<b>.0</b>
Structural Grade:	<b>0</b>
O&M Grade:	<b>0</b>
Clock Start/From:	
Clock To:	
1st Value:	
2nd Value:	
Value Percent:	
Step:	<b>NO</b>
Remarks:	<b>ACCESS MH</b>

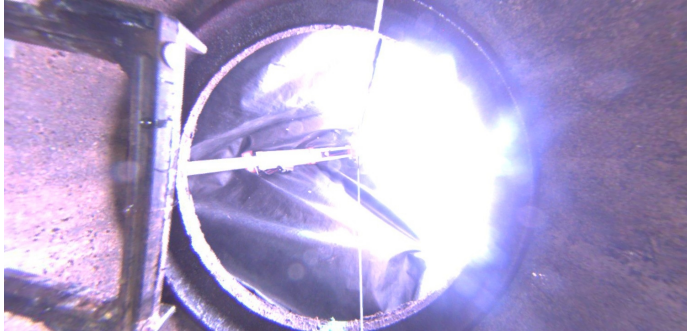
Code:	<b>MGO</b>
Description:	<b>General Observation</b>
Distance (ft):	<b>1.4</b>
Structural Grade:	<b>0</b>
O&M Grade:	<b>0</b>
Clock Start/From:	
Clock To:	
1st Value:	
2nd Value:	
Value Percent:	
Step:	<b>NO</b>
Remarks:	<b>UNDERSIDE OF FRAME</b>

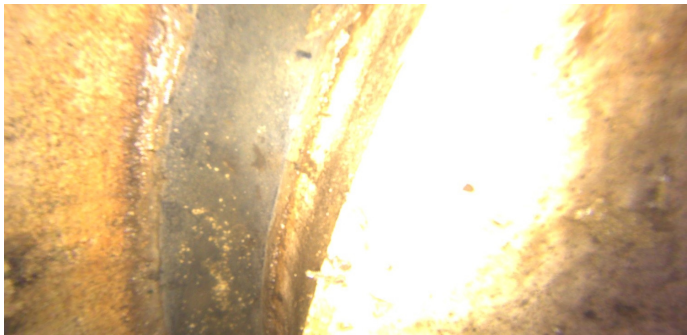
Code:	<b>MGO</b>
Description:	<b>General Observation</b>
Distance (ft):	<b>5.4</b>
Structural Grade:	<b>0</b>
O&M Grade:	<b>0</b>
Clock Start/From:	
Clock To:	
1st Value:	
2nd Value:	
Value Percent:	
Step:	<b>NO</b>
Remarks:	<b>END SURVEY</b>
