Manhole Inspection Report

Date:	05/11/2018	Weather:		Coding:	RZMACP
MH#:	M-1004-072	Owner:	NA	Len. Surveyed:	5.3
P.O.#:		Surveyor:	Jen Costello	Rim to Invert:	5.3
Customer:		Cert. #:	U-907-5518	Wall Material:	Concrete (reinforced)

Street:	Tulip Ln. 1099' East of Union St.	Project:	Hobart, IN
City:	Hobart, IN	GPS Northing:	2913461.29
Location:		GPS Easting:	2913461.29
Drain Area:	Northeast	GPS Accuracy:	Sub-Meter
Cover Shape:	Circular	Evidence of Surcharge:	No
Cover Size:	22.5	Potential for Runoff:	None
Comments:

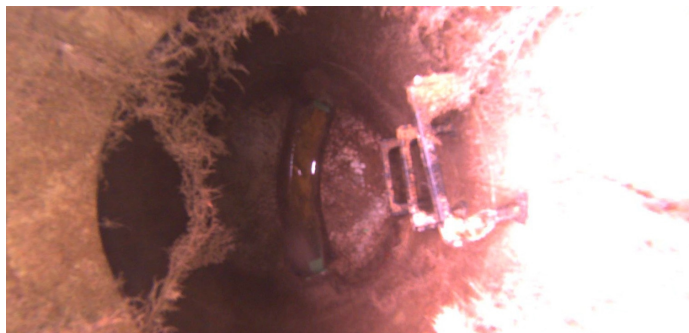
Code: **MGP**
Description: **General Photo**

Distance (ft): **.0**
Structural Grade: **0**
O&M Grade: **0**
Clock Start/From:
Clock To:
1st Value:
2nd Value:
Value Percent:
Step: **NO**
Remarks: **ACCESS MH**

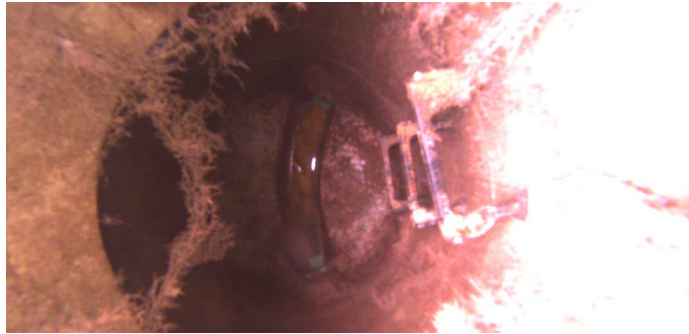
Code: **RFJ**
Description: **Roots Fine Joint**

Distance (ft): **.0**
Structural Grade: **0**
O&M Grade: **1**
Clock Start/From: **12**
Clock To: **12**
1st Value:
2nd Value:
Value Percent:
Step: **NO**
Remarks:

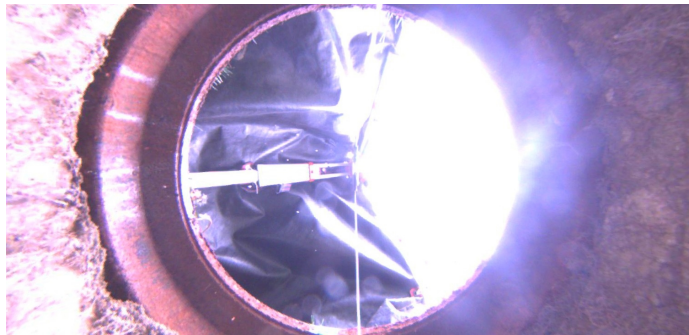
Code: **MGO**
Description: **General Observation**

Distance (ft): **1.8**
Structural Grade: **0**
O&M Grade: **0**
Clock Start/From:
Clock To:
1st Value:
2nd Value:
Value Percent:
Step: **NO**
Remarks: **UNDERSIDE OF FRAME**

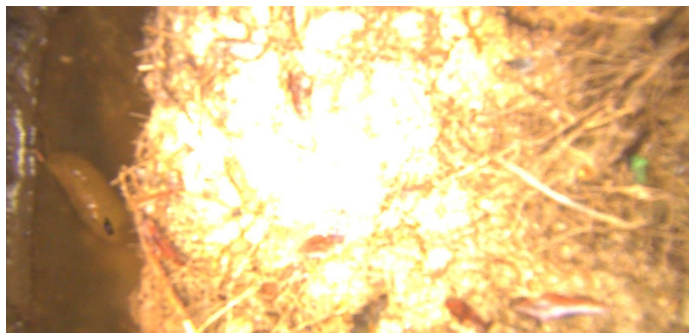
Code: **MGO**
Description: **General Observation**

Distance (ft): **5.3**
Structural Grade: **0**
O&M Grade: **0**
Clock Start/From:
Clock To:
1st Value:
2nd Value:
Value Percent:
Step: **NO**
Remarks: **END SURVEY**
