# Manhole Inspection Report

Date:	05/11/2018	Weather:		Coding:	RZMACP
MH#:	M-1004-073	Owner:	NA	Len. Surveyed:	4.4
P.O.#:		Surveyor:	Jen Costello	Rim to Invert:	5.4
Customer:		Cert. #:	U-907-5518	Wall Material:	Concrete (reinforced)

Street:	Tulip Ln. 392' West of Hemlock Dr.	Project:	Hobart, IN
City:	Hobart, IN	GPS Northing:	2913498.734
Location:		GPS Easting:	2913498.734
Drain Area:	Northeast	GPS Accuracy:	Sub-Meter
Cover Shape:	Circular	Evidence of Surcharge:	No
Cover Size:	22.5	Potential for Runoff:	None
Comments:

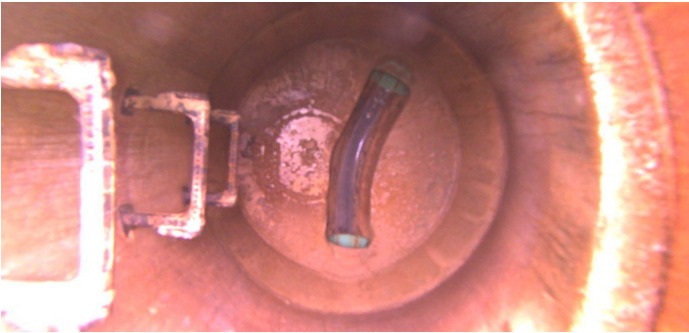
MGP

General Photo

ACCESS MH

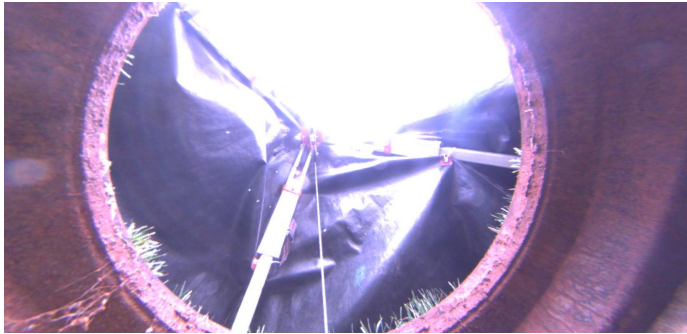
Code: **MGO**  
Description: **General Observation**

Distance (ft): **1.1**  
Structural Grade: **0**  
O&M Grade: **0**  
Clock Start/From:  
Clock To:  
1st Value:  
2nd Value:  
Value Percent:  
Step: **NO**  
Remarks: **UNDERSIDE OF FRAME**

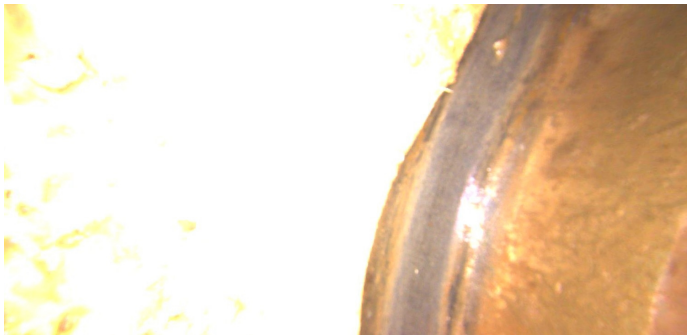
Code: **MGO**  
Description: **General Observation**

Distance (ft): **4.4**  
Structural Grade: **0**  
O&M Grade: **0**  
Clock Start/From:  
Clock To:  
1st Value:  
2nd Value:  
Value Percent:  
Step: **NO**  
Remarks: **END SURVEY**
