Manhole Inspection Report

Date:	05/11/2018	Weather:		Coding:	RZMACP
MH#:	M-1004-076	Owner:	NA	Len. Surveyed:	3.6
P.O.#:		Surveyor:	Jen Costello	Rim to Invert:	4.4
Customer:		Cert. #:	U-907-5518	Wall Material:	Concrete (reinforced)

Street:	Tulip Ln. 167' West of Hemlock Dr.	Project:	Hobart, IN
City:	Hobart, IN	GPS Northing:	2913719.385
Location:		GPS Easting:	2913719.385
Drain Area:	Northeast	GPS Accuracy:	Sub-Meter
Cover Shape:	Circular	Evidence of Surcharge:	No
Cover Size:	22.5	Potential for Runoff:	None
Comments:

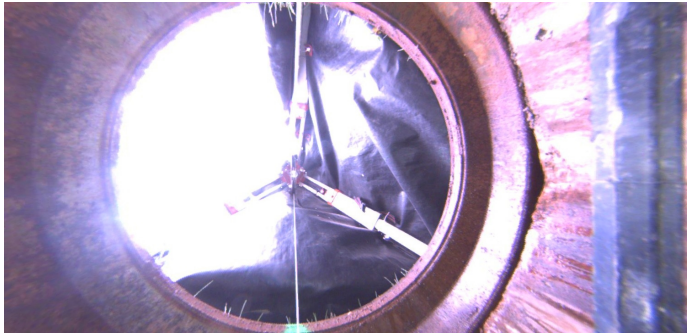
Code: **MGO**
Description: **General Observation**

Distance (ft): **1.3**
Structural Grade: **0**
O&M Grade: **0**
Clock Start/From:
Clock To:
1st Value:
2nd Value:
Value Percent:
Step: **NO**
Remarks: **UNDERSIDE OF FRAME**

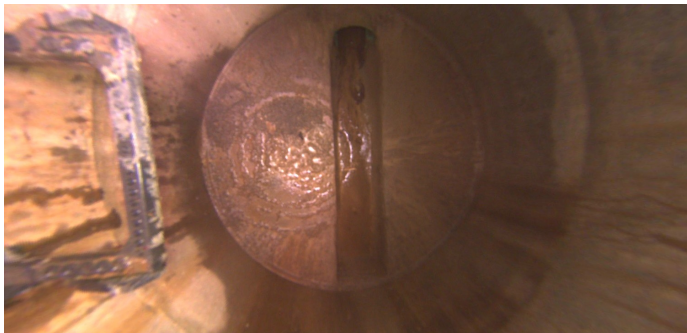
Code: **IS**
Description: **Infil Stain**

Distance (ft): **1.3**
Structural Grade: **0**
O&M Grade: **0**
Clock Start/From: **12**
Clock To: **12**
1st Value:
2nd Value:
Value Percent:
Step: **NO**
Remarks:

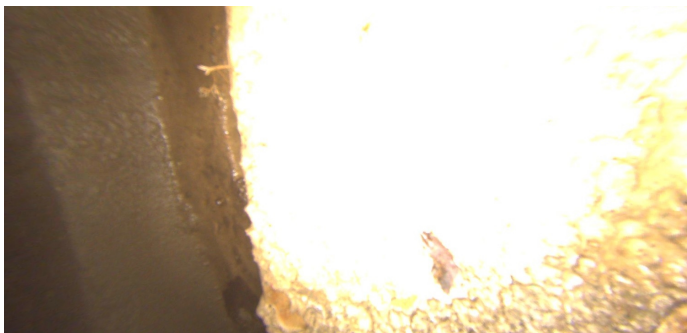
Code: **MGO**
Description: **General Observation**

Distance (ft): **3.6**
Structural Grade: **0**
O&M Grade: **0**
Clock Start/From:
Clock To:
1st Value:
2nd Value:
Value Percent:
Step: **NO**
Remarks: **END SURVEY**
