Manhole Inspection Report

Date:	05/11/2018	Weather:		Coding:	RZMACP
MH#:	M-1004-077	Owner:	NA	Len. Surveyed:	10.8
P.O.#:		Surveyor:	Jen Costello	Rim to Invert:	12.1
Customer:		Cert. #:	U-907-5518	Wall Material:	Concrete (reinforced)

Street:	Hemlock Dr. North of Tulip Ln.	Project:	Hobart, IN
City:	Hobart, IN	GPS Northing:	2913834.41
Location:		GPS Easting:	2913834.41
Drain Area:	Northeast	GPS Accuracy:	Sub-Meter
Cover Shape:	Circular	Evidence of Surcharge:	No
Cover Size:	22.5	Potential for Runoff:	None
Comments:

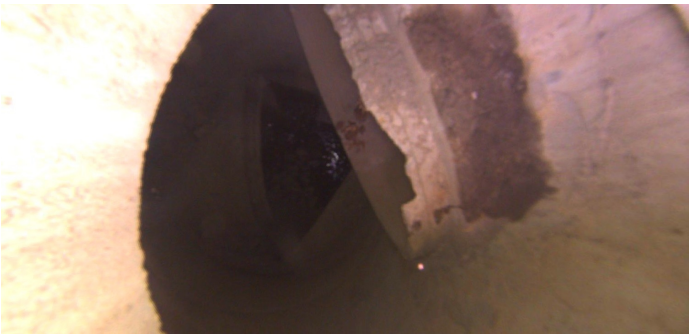
Code: **MGP**
 Description: **General Photo**

Distance (ft): **.0**
 Structural Grade: **0**
 O&M Grade: **0**
 Clock Start/From:
 Clock To:
 1st Value:
 2nd Value:
 Value Percent:
 Step: **NO**
 Remarks: **ACCESS MH**

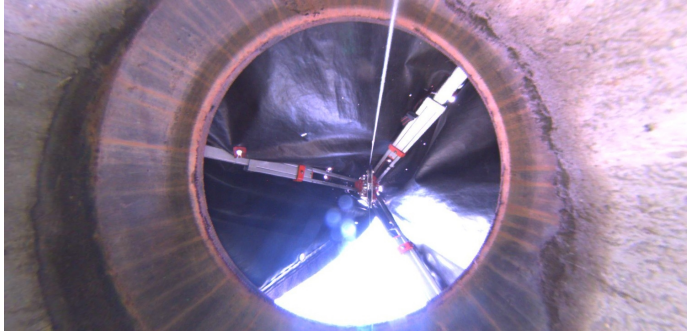
Code: **MGO**
Description: **General Observation**

Distance (ft): **1.1**
Structural Grade: **0**
O&M Grade: **0**
Clock Start/From:
Clock To:
1st Value:
2nd Value:
Value Percent:
Step: **NO**
Remarks: **UNDERSIDE OF FRAME**

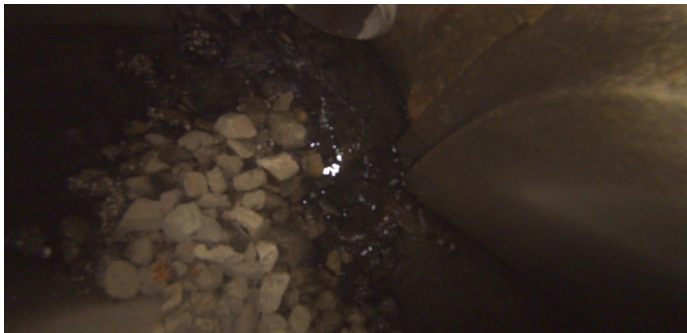
Code: **OBR**
Description: **Obstacle Rocks**

Distance (ft): **8.2**
Structural Grade: **0**
O&M Grade: **2**
Clock Start/From: **6**
Clock To: **12**
1st Value:
2nd Value:
Value Percent: **10.000**
Step: **NO**
Remarks:

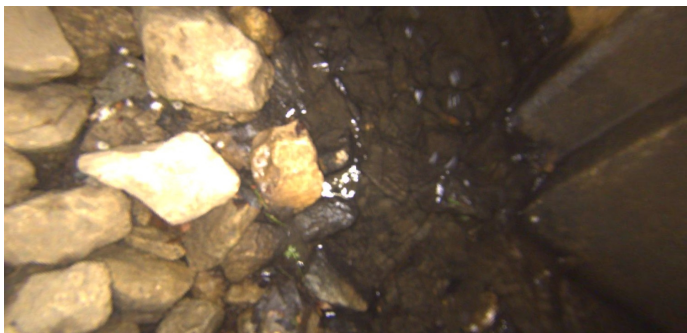
Code: **MGO**
Description: **General Observation**

Distance (ft): **10.8**
Structural Grade: **0**
O&M Grade: **0**
Clock Start/From:
Clock To:
1st Value:
2nd Value:
Value Percent:
Step: **NO**
Remarks: **END SURVEY**
