Manhole Inspection Report

Date:	05/11/2018	Weather:		Coding:	RZMACP
MH#:	M-1004-085	Owner:	NA	Len. Surveyed:	8.4
P.O.#:		Surveyor:	Jen Costello	Rim to Invert:	9.2
Customer:		Cert. #:	U-907-5518	Wall Material:	Concrete (reinforced)

Street:	Cypress Ln. and Hemlock Dr.	Project:	Hobart, IN
City:	Hobart, IN	GPS Northing:	41.54133224
Location:		GPS Easting:	-87.22542572
Drain Area:	Northeast	GPS Accuracy:	Nearest Meter
Cover Shape:	Circular	Evidence of Surcharge:	No
Cover Size:	22.5	Potential for Runoff:	None
Comments:

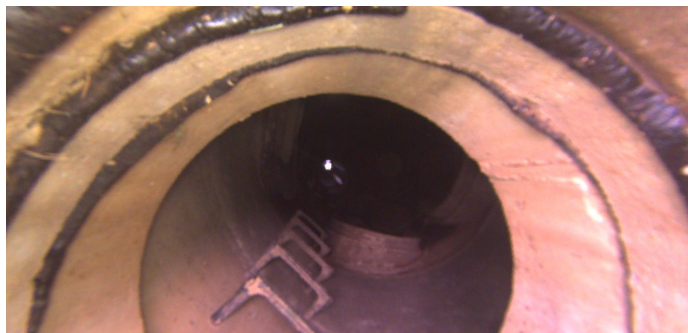
Code: **MGP**
Description: **General Photo**

Distance (ft): **.0**
Structural Grade: **0**
O&M Grade: **0**
Clock Start/From:
Clock To:
1st Value:
2nd Value:
Value Percent:
Step: **NO**
Remarks: **access mh**

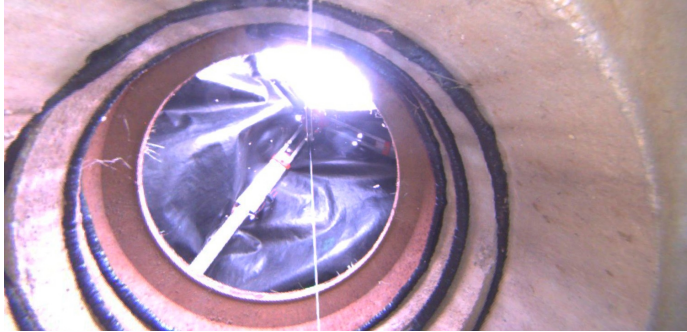
Code: **MGO**
Description: **General Observation**

Distance (ft): **2.3**
Structural Grade: **0**
O&M Grade: **0**
Clock Start/From:
Clock To:
1st Value:
2nd Value:
Value Percent:
Step: **NO**
Remarks: **underside of frame**

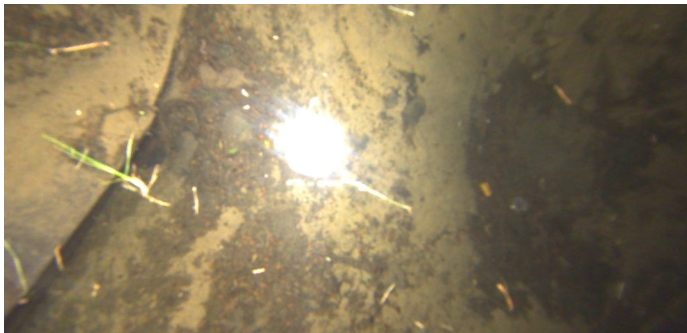
Code: **MGO**
Description: **General Observation**

Distance (ft): **8.4**
Structural Grade: **0**
O&M Grade: **0**
Clock Start/From:
Clock To:
1st Value:
2nd Value:
Value Percent:
Step: **NO**
Remarks: **end survey**
