Manhole Inspection Report

Date:	05/11/2018	Weather:		Coding:	RZMACP
MH#:	M-1004-086	Owner:	NA	Len. Surveyed:	4.0
P.O.#:		Surveyor:	Jen Costello	Rim to Invert:	4.4
Customer:		Cert. #:	U-907-5518	Wall Material:	Concrete (reinforced)

Street:	Cypress Ln. 166' West of Hemlock Dr	Project:	Hobart, IN
City:	Hobart, IN	GPS Northing:	2913720.342
Location:		GPS Easting:	2913720.342
Drain Area:	Northeast	GPS Accuracy:	Sub-Meter
Cover Shape:	Circular	Evidence of Surcharge:	No
Cover Size:	22.5	Potential for Runoff:	None
Comments:

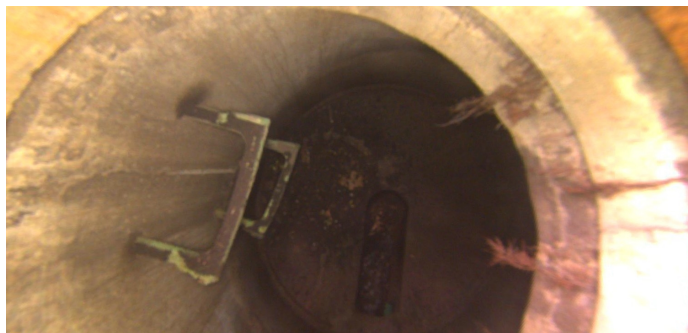
Code: **MGP**
Description: **General Photo**

Distance (ft): **.0**
Structural Grade: **0**
O&M Grade: **0**
Clock Start/From:
Clock To:
1st Value:
2nd Value:
Value Percent:
Step: **NO**
Remarks: **ACCESS MH**

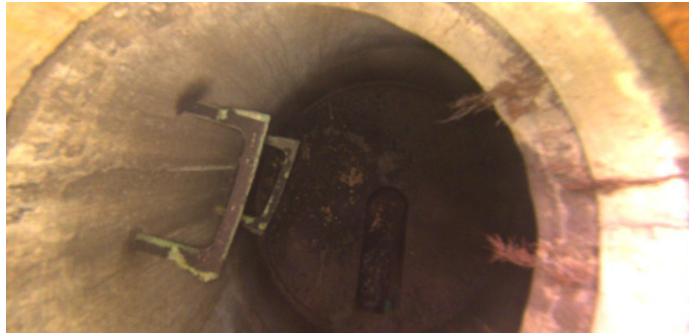
Code: **RFJ**
Description: **Roots Fine Joint**

Distance (ft): **.0**
Structural Grade: **0**
O&M Grade: **1**
Clock Start/From: **2**
Clock To: **3**
1st Value:
2nd Value:
Value Percent:
Step: **NO**
Remarks:

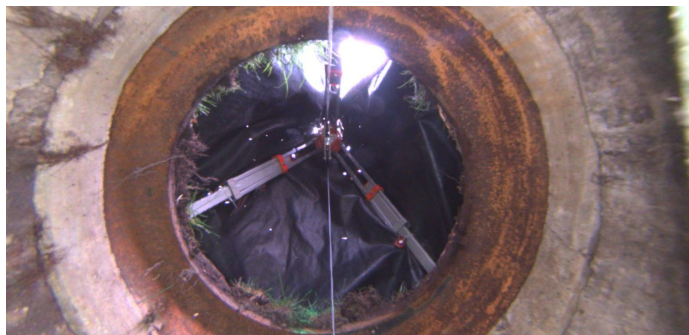
Code: **MGO**
Description: **General Observation**

Distance (ft): **2.0**
Structural Grade: **0**
O&M Grade: **0**
Clock Start/From:
Clock To:
1st Value:
2nd Value:
Value Percent:
Step: **NO**
Remarks: **END SURVEY**

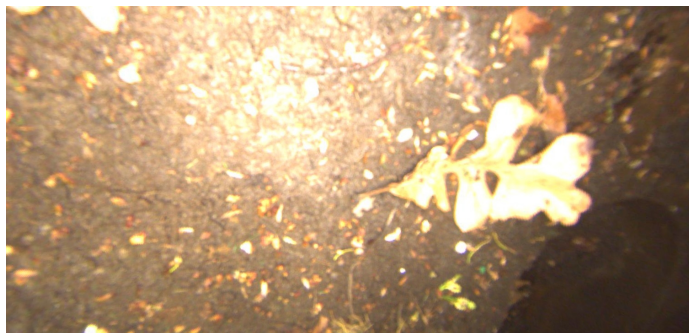
Code: **MGP**
Description: **General Photo**

Distance (ft): **4.0**
Structural Grade: **0**
O&M Grade: **0**
Clock Start/From:
Clock To:
1st Value:
2nd Value:
Value Percent:
Step: **NO**
Remarks: **END SURVEY**
