# Manhole Inspection Report

Date:	<b>05/11/2018</b>	Weather:		Coding:	<b>RZMACP</b>
MH#:	<b>M-1004-088</b>	Owner:	<b>NA</b>	Len. Surveyed:	<b>4.7</b>
P.O.#:		Surveyor:	<b>Jen Costello</b>	Rim to Invert:	<b>5.5</b>
Customer:		Cert. #:	<b>U-907-5518</b>	Wall Material:	<b>Concrete (reinforced)</b>

Street:	<b>Cypress Ln. 521' West of Hemlock Dr</b>	Project:	<b>Hobart, IN</b>
City:	<b>Hobart, IN</b>	GPS Northing:	<b>2913374.702</b>
Location:		GPS Easting:	<b>2913374.702</b>
Drain Area:	<b>Northeast</b>	GPS Accuracy:	<b>Sub-Meter</b>
Cover Shape:	<b>Circular</b>	Evidence of Surcharge:	<b>No</b>
Cover Size:	<b>22.5</b>	Potential for Runoff:	<b>None</b>
Comments:

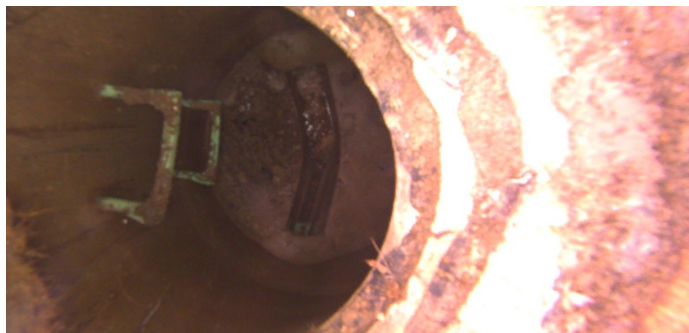
Code: **MGP**  
Description: **General Photo**

Distance (ft): **.0**  
Structural Grade: **0**  
O&M Grade: **0**  
Clock Start/From:  
Clock To:  
1st Value:  
2nd Value:  
Value Percent:  
Step: **NO**  
Remarks: **ACCESS MH**

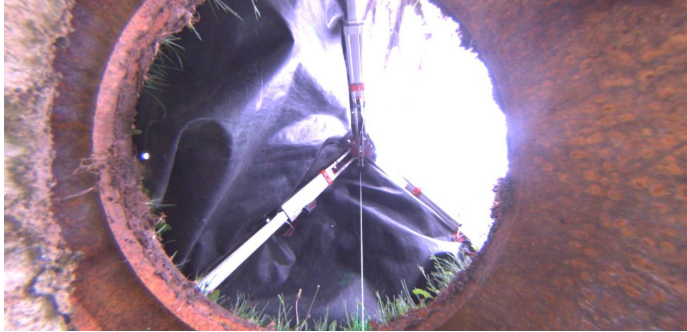
Code: **MGO**  
Description: **General Observation**

Distance (ft): **1.2**  
Structural Grade: **0**  
O&M Grade: **0**  
Clock Start/From:  
Clock To:  
1st Value:  
2nd Value:  
Value Percent:  
Step: **NO**  
Remarks: **UNDERSIDE OF FRAME**

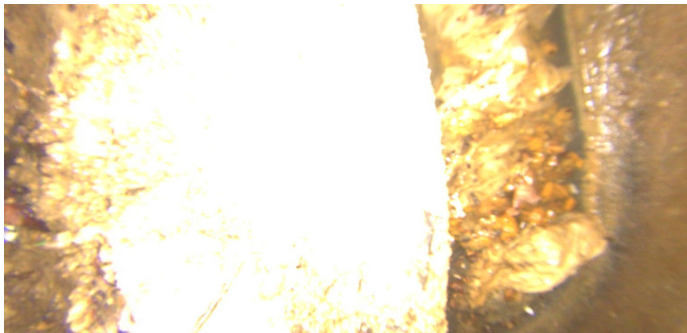
Code: **MGO**  
Description: **General Observation**

Distance (ft): **4.7**  
Structural Grade: **0**  
O&M Grade: **0**  
Clock Start/From:  
Clock To:  
1st Value:  
2nd Value:  
Value Percent:  
Step: **NO**  
Remarks: **END SURVEY**
