Manhole Inspection Report

Date:	05/11/2018	Weather:		Coding:	RZMACP
MH#:	M-1004-089	Owner:	NA	Len. Surveyed:	6.3
P.O.#:		Surveyor:	Jen Costello	Rim to Invert:	6.8
Customer:		Cert. #:	U-907-5518	Wall Material:	Concrete (reinforced)

Street:	Cypress Ln. 640' West of Hemlock Dr	Project:	Hobart, IN
City:	Hobart, IN	GPS Northing:	2913237.269
Location:		GPS Easting:	2913237.269
Drain Area:	Northeast	GPS Accuracy:	Sub-Meter
Cover Shape:	Circular	Evidence of Surcharge:	No
Cover Size:	22.5	Potential for Runoff:	None
Comments:

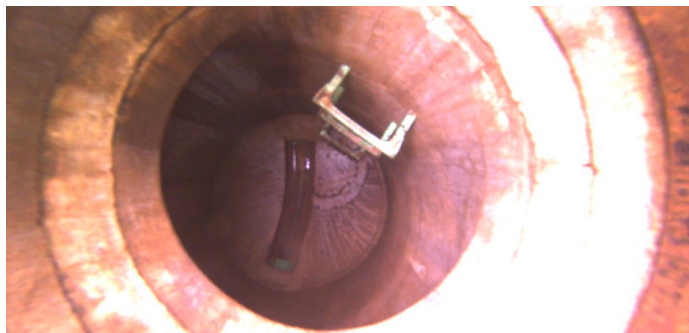
Code: **MGO**
Description: **General Observation**

Distance (ft): **.0**
Structural Grade: **0**
O&M Grade: **0**
Clock Start/From:
Clock To:
1st Value:
2nd Value:
Value Percent:
Step: **NO**
Remarks: **ACCESS MH**

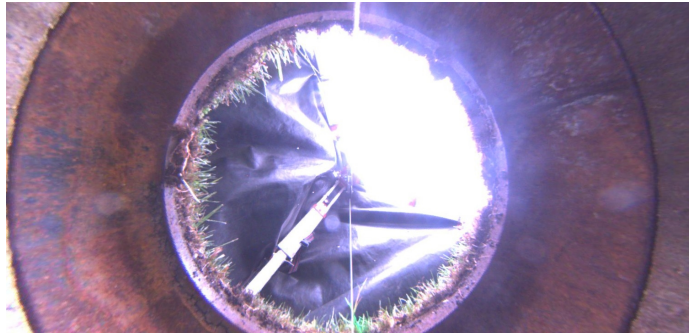
Code: **MGO**
Description: **General Observation**

Distance (ft): **1.6**
Structural Grade: **0**
O&M Grade: **0**
Clock Start/From:
Clock To:
1st Value:
2nd Value:
Value Percent:
Step: **NO**
Remarks: **UNDERSIDE OF FRAME**

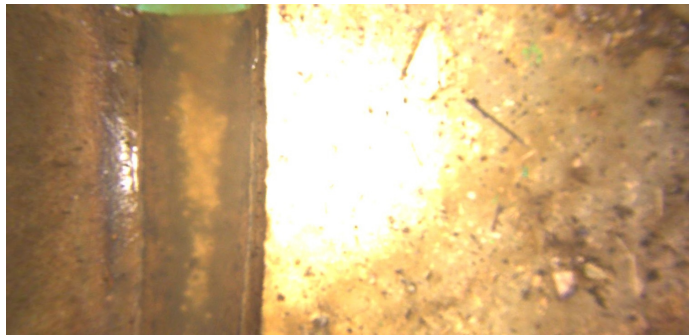
Code: **MGO**
Description: **General Observation**

Distance (ft): **6.3**
Structural Grade: **0**
O&M Grade: **0**
Clock Start/From:
Clock To:
1st Value:
2nd Value:
Value Percent:
Step: **NO**
Remarks: **END SURVEY**
