Manhole Inspection Report

Date:	05/11/2018	Weather:		Coding:	RZMACP
MH#:	M-1004-092	Owner:	NA	Len. Surveyed:	7.1
P.O.#:		Surveyor:	Jen Costello	Rim to Invert:	7.2
Customer:		Cert. #:	U-907-5518	Wall Material:	Concrete (reinforced)

Street:	Cypress Ln. 378' East of Poplar Ln.	Project:	Hobart, IN
City:	Hobart, IN	GPS Northing:	2912941.119
Location:		GPS Easting:	2912941.119
Drain Area:	Northeast	GPS Accuracy:	Sub-Meter
Cover Shape:	Circular	Evidence of Surcharge:	No
Cover Size:	22.5	Potential for Runoff:	None
Comments:

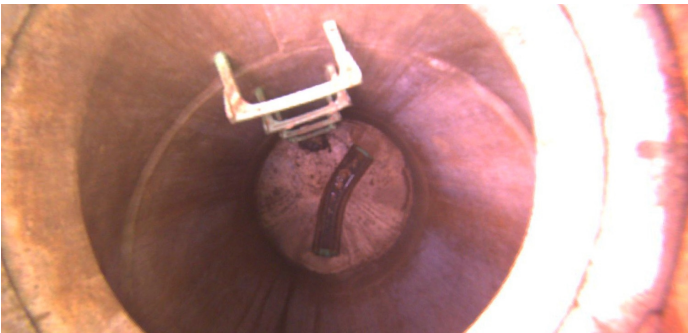
Code:	MGP
Description:	General Photo
Distance (ft):	.0
Structural Grade:	0
O&M Grade:	0
Clock Start/From:	
Clock To:	
1st Value:	
2nd Value:	
Value Percent:	
Step:	NO
Remarks:	ACCESS MH

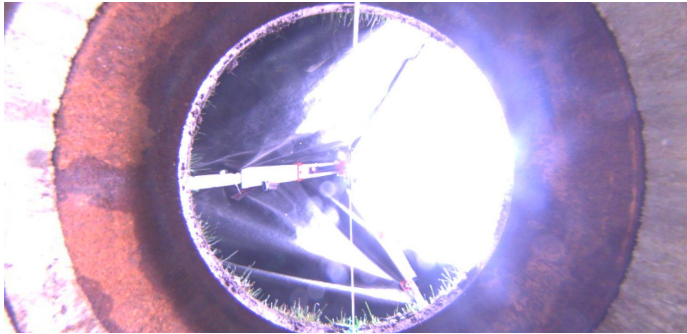
Code: **MGO**
Description: **General Observation**

Distance (ft): **1.6**
Structural Grade: **0**
O&M Grade: **0**
Clock Start/From:
Clock To:
1st Value:
2nd Value:
Value Percent:
Step: **NO**
Remarks: **UNDERSIDE OF FRAME**
