# Manhole Inspection Report

Date:	05/11/2018	Weather:		Coding:	RZMACP
MH#:	M-1004-094	Owner:	NA	Len. Surveyed:	7.9
P.O.#:		Surveyor:	Jen Costello	Rim to Invert:	8.5
Customer:		Cert. #:	U-907-5518	Wall Material:	Concrete (reinforced)

Street:	Hillcrest Ave. 220' North of Barberry	Project:	Hobart, IN
City:	Hobart, IN	GPS Northing:	2912837.731
Location:		GPS Easting:	2912837.731
Drain Area:	Northeast	GPS Accuracy:	Sub-Meter
Cover Shape:	Circular	Evidence of Surcharge:	No
Cover Size:	22.5	Potential for Runoff:	None
Comments:

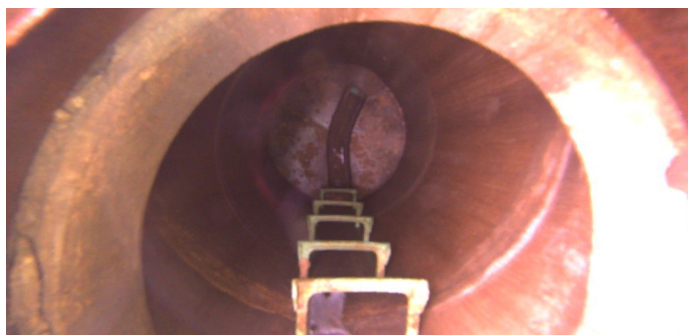
Code:	<b>MGP</b>
Description:	<b>General Photo</b>
Distance (ft):	<b>.0</b>
Structural Grade:	<b>0</b>
O&M Grade:	<b>0</b>
Clock Start/From:	
Clock To:	
1st Value:	
2nd Value:	
Value Percent:	
Step:	<b>NO</b>
Remarks:	<b>ACCESS MH</b>

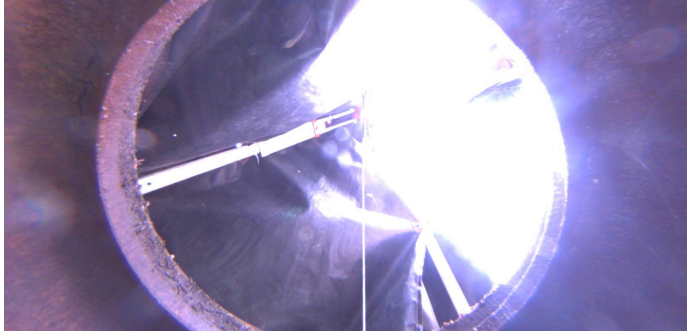
Code:	<b>MGO</b>
Description:	<b>General Observation</b>
Distance (ft):	<b>1.1</b>
Structural Grade:	<b>0</b>
O&M Grade:	<b>0</b>
Clock Start/From:	
Clock To:	
1st Value:	
2nd Value:	
Value Percent:	
Step:	<b>NO</b>
Remarks:	<b>UNDERSIDE OF FRAME</b>

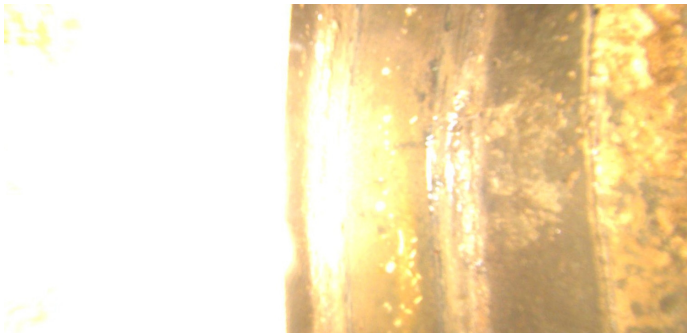
Code:	<b>MGO</b>
Description:	<b>General Observation</b>
Distance (ft):	<b>7.9</b>
Structural Grade:	<b>0</b>
O&M Grade:	<b>0</b>
Clock Start/From:	
Clock To:	
1st Value:	
2nd Value:	
Value Percent:	
Step:	<b>NO</b>
Remarks:	<b>END SURVEY</b>
