Manhole Inspection Report

Date:	05/08/2018	Weather:		Coding:	RZMACP
MH#:	M-1004-097	Owner:	NA	Len. Surveyed:	7.2
P.O.#:		Surveyor:	Jen Costello	Rim to Invert:	7.8
Customer:		Cert. #:	U-907-5518	Wall Material:	Concrete (reinforced)

Street:	Eastin Ave. 271' North of Cleveland	Project:	Hobart, IN
City:	Hobart, IN	GPS Northing:	2914272.486
Location:		GPS Easting:	2914272.486
Drain Area:	Northeast	GPS Accuracy:	Sub-Meter
Cover Shape:	Circular	Evidence of Surcharge:	No
Cover Size:	22.5	Potential for Runoff:	None
Comments:

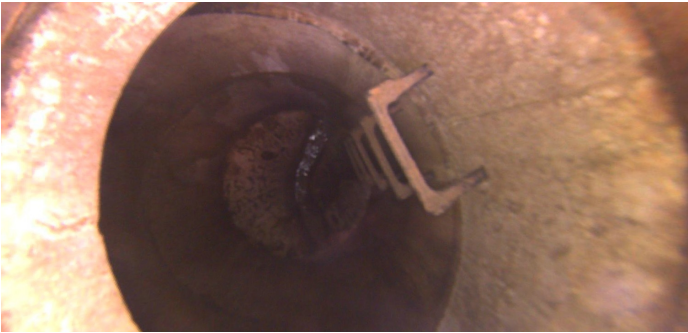
Code:

MGP

Description:

General Photo

Distance (ft):

.0

Remarks:

ACCESS MH

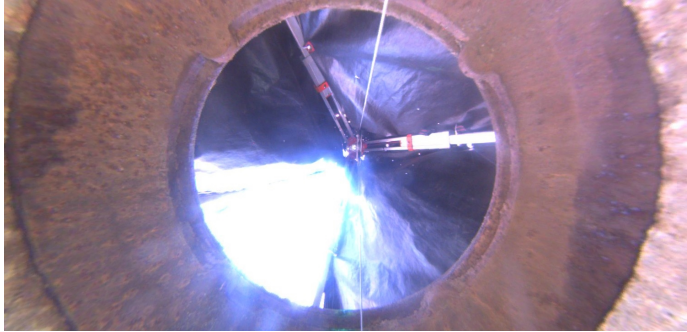
Code: **MGO**
Description: **General Observation**

Distance (ft): **1.4**
Structural Grade: **0**
O&M Grade: **0**
Clock Start/From:
Clock To:
1st Value:
2nd Value:
Value Percent:
Step: **NO**
Remarks: **UNDERSIDE OF FRAME**

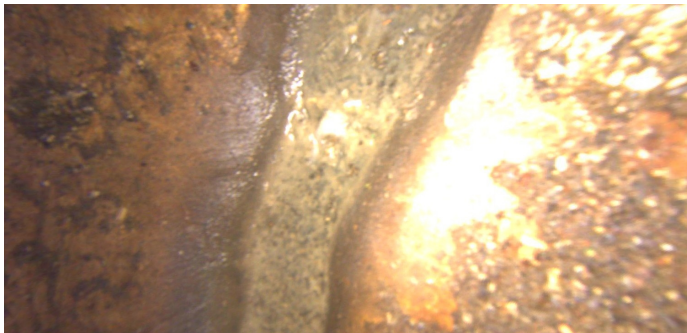
Code: **MGO**
Description: **General Observation**

Distance (ft): **7.2**
Structural Grade: **0**
O&M Grade: **0**
Clock Start/From:
Clock To:
1st Value:
2nd Value:
Value Percent:
Step: **NO**
Remarks: **END SURVEY**
