Manhole Inspection Report

| MH#: | M-1004-098 | Owner: | NA | Len. Surveyed: | 3.9 |

| Street: | The West Side of Union St. 168' Nort | Project: | Hobart, IN |

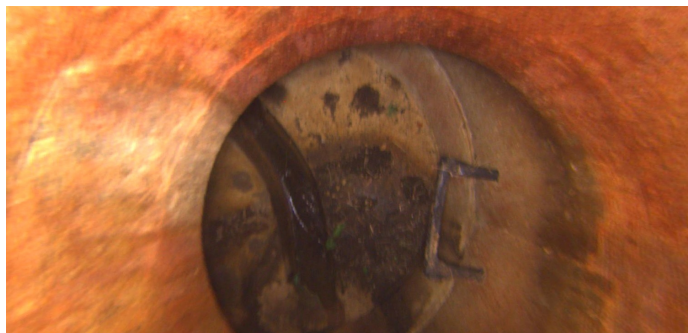
Code: **MGO**
 Description: **General Observation**

Distance (ft): **.0**
 Structural Grade: **0**
 O&M Grade: **0**
 Clock Start/From:
 Clock To:
 1st Value:
 2nd Value:
 Value Percent:
 Step: **NO**
 Remarks: **access mh**

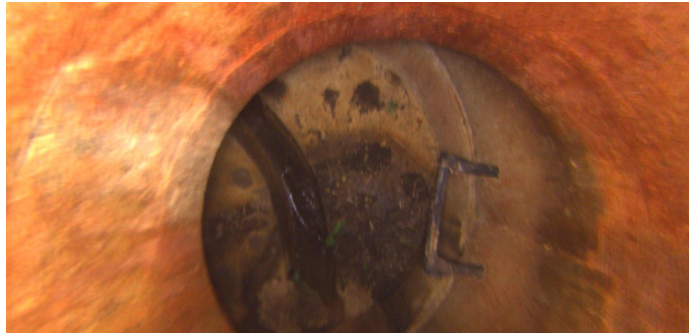
Code: **SRI**
Description: **Surface Roughness Increased**

Distance (ft): **.0**
Structural Grade: **1**
O&M Grade: **0**
Clock Start/From: **12**
Clock To: **12**
1st Value:
2nd Value:
Value Percent:
Step: **NO**
Remarks:

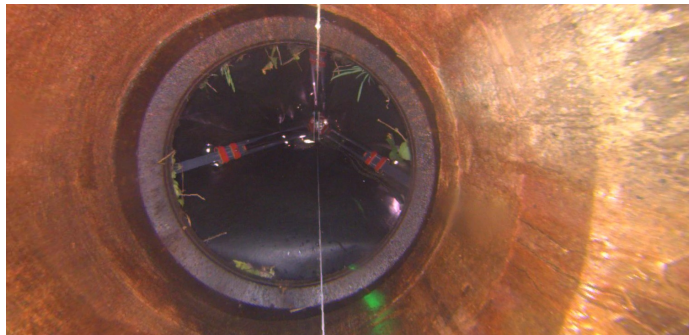
Code: **MGO**
Description: **General Observation**

Distance (ft): **2.2**
Structural Grade: **0**
O&M Grade: **0**
Clock Start/From:
Clock To:
1st Value:
2nd Value:
Value Percent:
Step: **NO**
Remarks: **underside of frame**

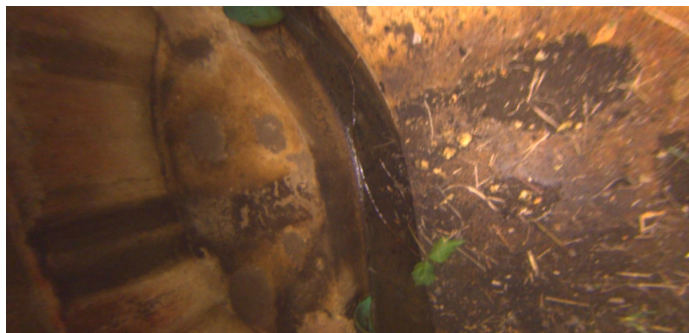
Code: **IW**
Description: **Infil Weeper**

Distance (ft): **2.2**
Structural Grade: **0**
O&M Grade: **2**
Clock Start/From: **8**
Clock To: **12**
1st Value:
2nd Value:
Value Percent:
Step: **NO**
Remarks:

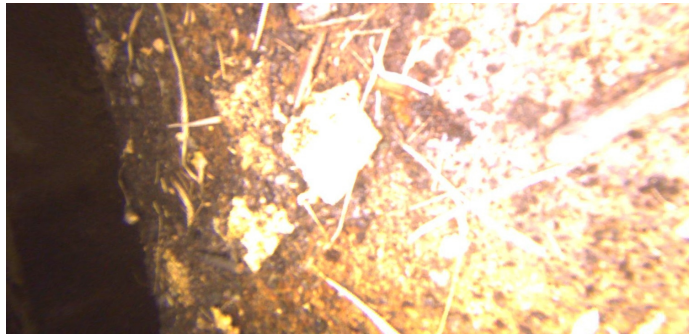
Code: **DSF**
Description: **Deposits Settled Fine**

Distance (ft): **3.9**
Structural Grade: **0**
O&M Grade: **2**
Clock Start/From: **12**
Clock To: **12**
1st Value:
2nd Value:
Value Percent: **5.000**
Step: **NO**
Remarks:

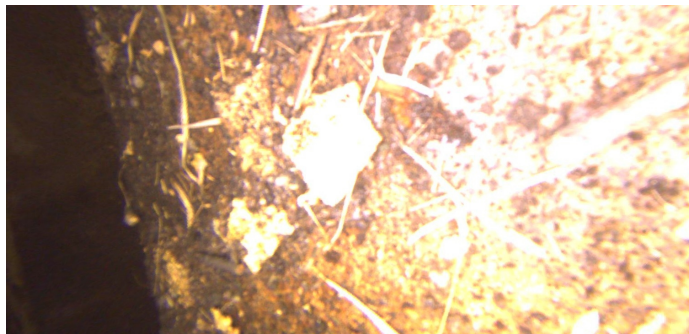
Code: **SRI**
Description: **Surface Roughness Increased**

Distance (ft): **3.9**
Structural Grade: **1**
O&M Grade: **0**
Clock Start/From: **12**
Clock To: **12**
1st Value:
2nd Value:
Value Percent:
Step: **NO**
Remarks:

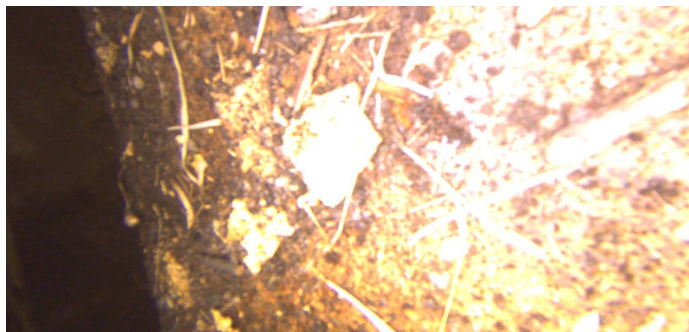
Code: **MGO**
Description: **General Observation**

Distance (ft): **3.9**
Structural Grade: **0**
O&M Grade: **0**
Clock Start/From:
Clock To:
1st Value:
2nd Value:
Value Percent:
Step: **NO**
Remarks: **end of survey**
