Manhole Inspection Report

Date:	05/08/2018	Weather:		Coding:	RZMACP
MH#:	M-1005-003	Owner:	NA	Len. Surveyed:	3.6
P.O.#:		Surveyor:	Jen Costello	Rim to Invert:	3.8
Customer:		Cert. #:	U-907-5518	Wall Material:	Concrete (reinforced)

Street:	685' South of Cleveland Ave. On Cou	Project:	Hobart, IN
City:	Hobart, IN	GPS Northing:	2915028.989
Location:		GPS Easting:	2915028.989
Drain Area:	Northeast	GPS Accuracy:	Sub-Meter
Cover Shape:	Circular	Evidence of Surcharge:	No
Cover Size:	22.5	Potential for Runoff:	None
Comments:

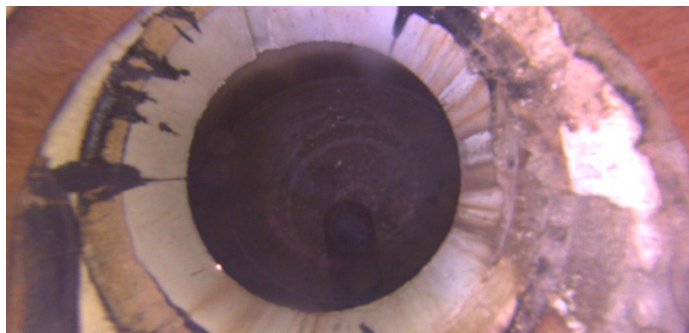
Code: **MGP**
Description: **General Photo**

Distance (ft): **.0**
Structural Grade: **0**
O&M Grade: **0**
Clock Start/From:
Clock To:
1st Value:
2nd Value:
Value Percent:
Step: **NO**
Remarks: **access MH**

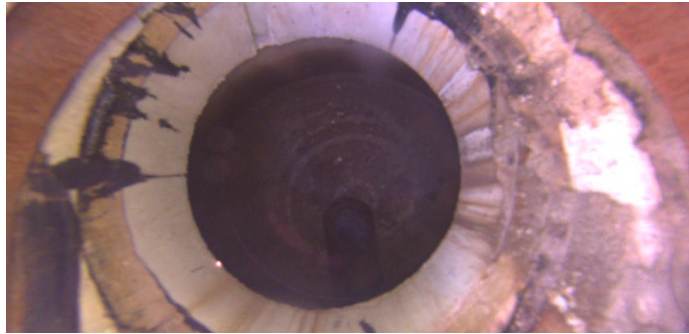
Code:	DAE
Description:	Deposits Attached Encrustation
Distance (ft):	.0
Structural Grade:	0
O&M Grade:	2
Clock Start/From:	1
Clock To:	4
1st Value:	
2nd Value:	
Value Percent:	5.000
Step:	NO
Remarks:

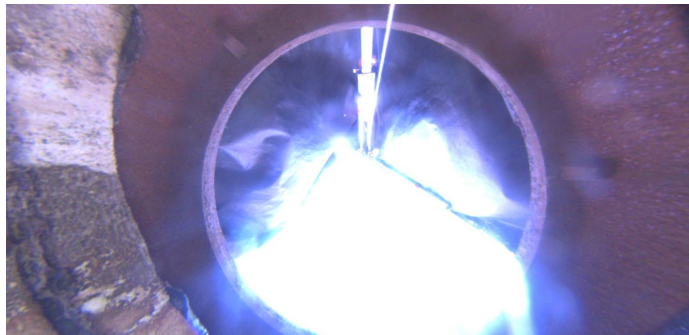
Code:	MGO
Description:	General Observation
Distance (ft):	1.5
Structural Grade:	0
O&M Grade:	0
Clock Start/From:	
Clock To:	
1st Value:	
2nd Value:	
Value Percent:	
Step:	NO
Remarks:	UNDERSIDE OF FRAME

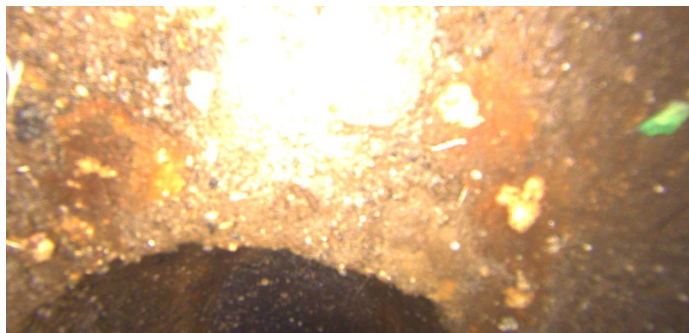
Code:	MGO
Description:	General Observation
Distance (ft):	3.6
Structural Grade:	0
O&M Grade:	0
Clock Start/From:	
Clock To:	
1st Value:	
2nd Value:	
Value Percent:	
Step:	NO
Remarks:	UNDERSIDE OF FRAME
