Manhole Inspection Report

Date:	05/08/2018	Weather:		Coding:	RZMACP
MH#:	M-1005-004	Owner:	NA	Len. Surveyed:	4.2
P.O.#:		Surveyor:	Jen Costello	Rim to Invert:	4.5
Customer:		Cert. #:	U-907-5518	Wall Material:	Concrete (reinforced)

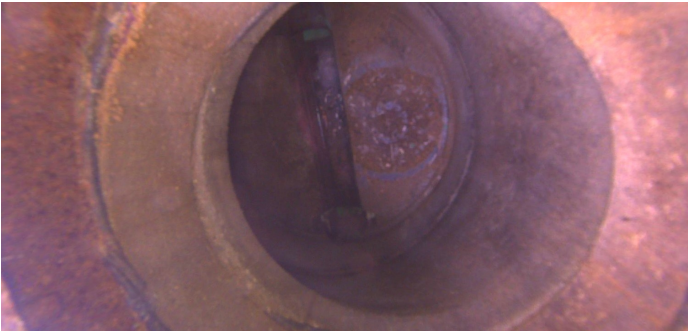
Code:	MGP
Description:	General Photo
Distance (ft):	.0
Structural Grade:	0
O&M Grade:	0
Clock Start/From:	
Clock To:	
1st Value:	
2nd Value:	
Value Percent:	
Step:	NO
Remarks:	ACCESS MH

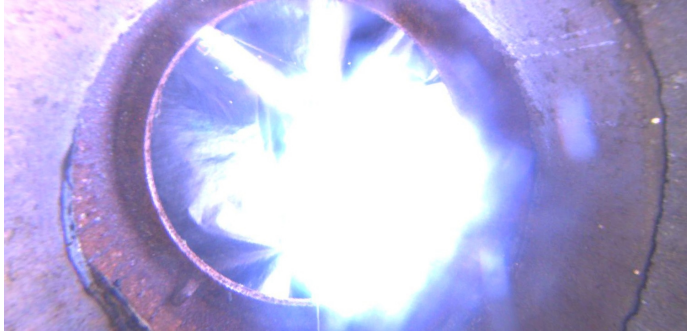
Code:	MGO
Description:	General Observation
Distance (ft):	2.2
Structural Grade:	0
O&M Grade:	0
Clock Start/From:	
Clock To:	
1st Value:	
2nd Value:	
Value Percent:	
Step:	NO
Remarks:	UNDERSIDE OF FRAME

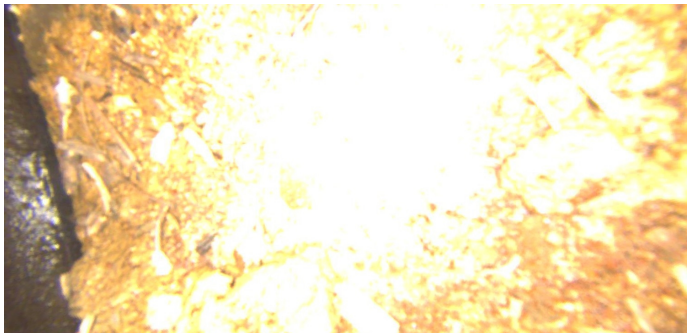
Code:	MGO
Description:	General Observation
Distance (ft):	4.2
Structural Grade:	0
O&M Grade:	0
Clock Start/From:	
Clock To:	
1st Value:	
2nd Value:	
Value Percent:	
Step:	NO
Remarks:	END SURVEY
