Manhole Inspection Report

Date:	05/08/2018	Weather:		Coding:	RZMACP
MH#:	M-1005-005	Owner:	NA	Len. Surveyed:	5.1
P.O.#:		Surveyor:	Jen Costello	Rim to Invert:	5.3
Customer:		Cert. #:	U-907-5518	Wall Material:	Concrete (reinforced)

Street:	Cleveland Ave. and County Line Rd.	Project:	Hobart, IN
City:	Hobart, IN	GPS Northing:	2915018.565
Location:		GPS Easting:	2915018.565
Drain Area:	Northeast	GPS Accuracy:	Sub-Meter
Cover Shape:	Circular	Evidence of Surcharge:	No
Cover Size:	22.5	Potential for Runoff:	None
Comments:

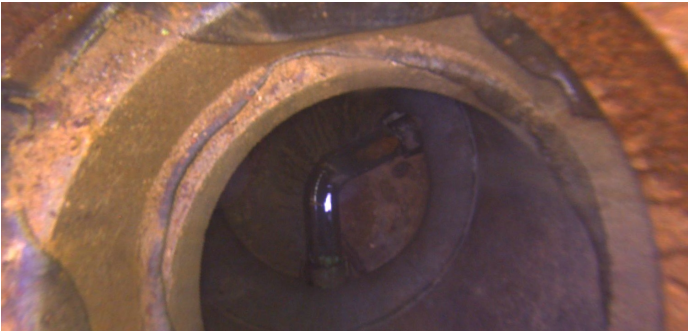
Code:	MGP
Description:	General Photo
Distance (ft):	.0
Structural Grade:	0
O&M Grade:	0
Clock Start/From:	
Clock To:	
1st Value:	
2nd Value:	
Value Percent:	
Step:	NO
Remarks:	access MH

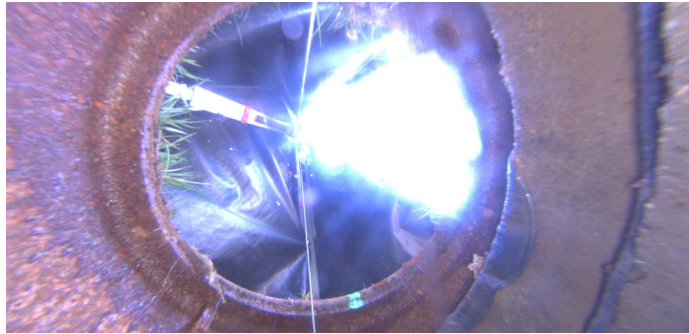
Code:	MGO
Description:	General Observation
Distance (ft):	1.7
Structural Grade:	0
O&M Grade:	0
Clock Start/From:	
Clock To:	
1st Value:	
2nd Value:	
Value Percent:	
Step:	NO
Remarks:	UNDERSIDE OF FRAME

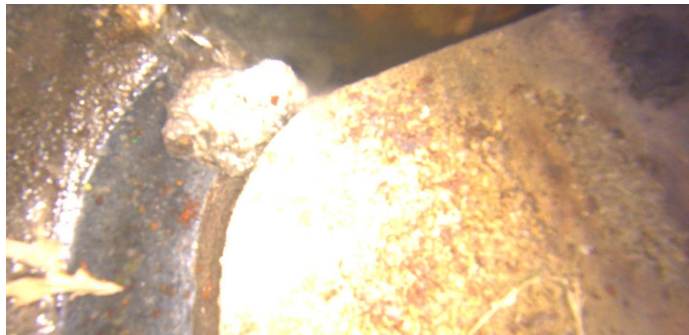
Code:	MGO
Description:	General Observation
Distance (ft):	5.1
Structural Grade:	0
O&M Grade:	0
Clock Start/From:	
Clock To:	
1st Value:	
2nd Value:	
Value Percent:	
Step:	NO
Remarks:	END SURVEY

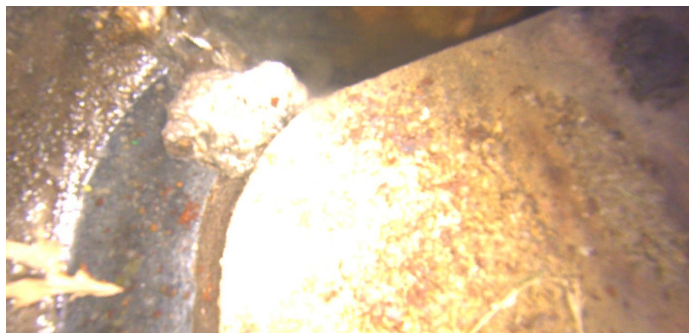
Code:	OBR
Description:	Obstacle Rocks
Distance (ft):	5.1
Structural Grade:	0
O&M Grade:	2
Clock Start/From:	12
Clock To:	
1st Value:	
2nd Value:	
Value Percent:	10.000
Step:	NO
Remarks:
