# Manhole Inspection Report

Date:	<b>04/22/2018</b>	Weather:		Coding:	<b>RZMACP</b>
MH#:	<b>M-1006-001</b>	Owner:	<b>NA</b>	Len. Surveyed:	<b>9.0</b>
P.O.#:		Surveyor:	<b>John Kuglmaier</b>	Rim to Invert:	<b>9.9</b>
Customer:	<b>8.7</b>	Cert. #:	<b>U-1215-07002349</b>	Wall Material:	<b>Concrete (reinforced)</b>

Street:	<b>N of Hwy 130. 2081' West The Coun</b>	Project:	<b>Hobart, IN</b>
City:	<b>Hobart, IN</b>	GPS Northing:	<b>0.0</b>
Location:		GPS Easting:	<b>0.0</b>
Drain Area:	<b>Southeast</b>	GPS Accuracy:	<b>Nearest Meter</b>
Cover Shape:	<b>Circular</b>	Evidence of Surcharge:	<b>No</b>
Cover Size:	<b>22.5</b>	Potential for Runoff:	<b>None</b>
Comments:

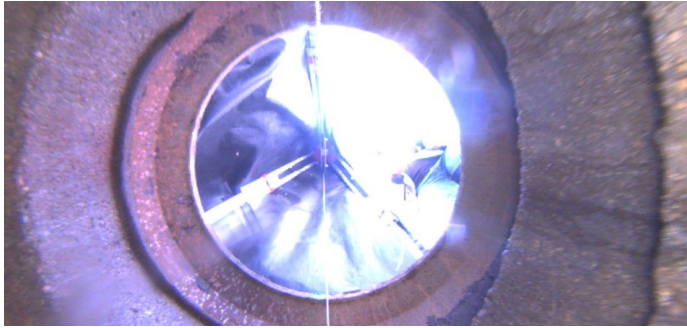
Code: **MGP**  
Description: **General Photo**

Distance (ft): **2.7**  
Structural Grade: **0**  
O&M Grade: **0**  
Clock Start/From:  
Clock To:  
1st Value:  
2nd Value:  
Value Percent:  
Step: **NO**  
Remarks:

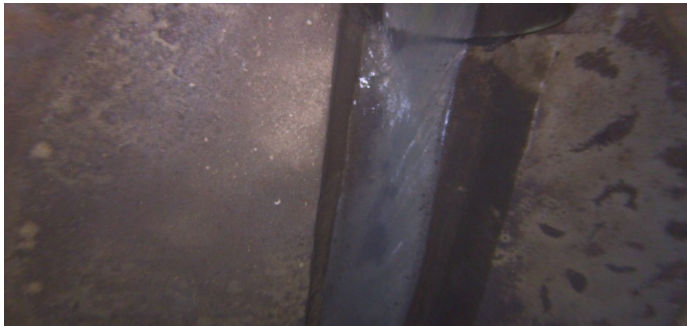
Code: **MGO**  
Description: **General Observation**

Distance (ft): **8.0**  
Structural Grade: **0**  
O&M Grade: **0**  
Clock Start/From:  
Clock To:  
1st Value:  
2nd Value:  
Value Percent:  
Step: **NO**  
Remarks: **Ins. Comp.**
