Manhole Inspection Report

| MH#: | M-1006-002 | Owner: | NA | Len. Surveyed: | 16.1 |

| Street: | North of 10th St. 354' West of Vermi | Project: | Hobart, IN |

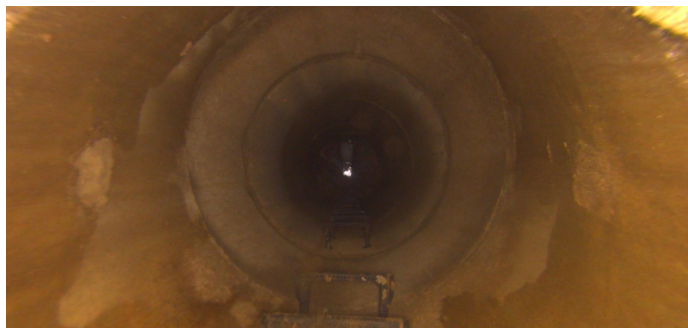
Code: **MGO**
Description: **General Observation**

Distance (ft): **.0**
Structural Grade: **0**
O&M Grade: **0**
Clock Start/From:
Clock To:
1st Value:
2nd Value:
Value Percent:
Step: **NO**
Remarks: **access mh**

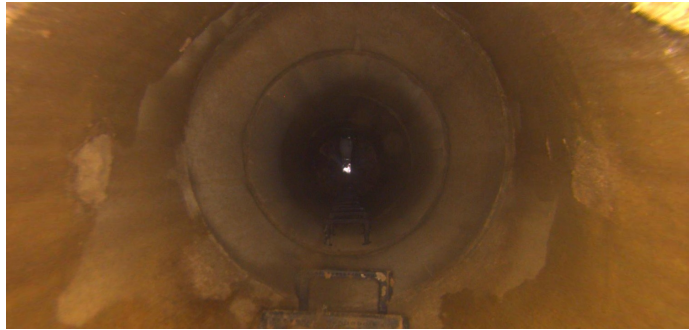
Code: **SRI**
Description: **Surface Roughness Increased**

Distance (ft): **.0**
Structural Grade: **1**
O&M Grade: **0**
Clock Start/From: **12**
Clock To: **12**
1st Value:
2nd Value:
Value Percent:
Step: **NO**
Remarks:

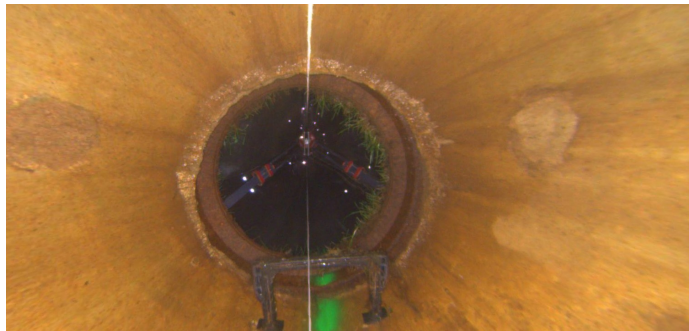
Code: **MGO**
Description: **General Observation**

Distance (ft): **3.1**
Structural Grade: **0**
O&M Grade: **0**
Clock Start/From:
Clock To:
1st Value:
2nd Value:
Value Percent:
Step: **NO**
Remarks: **underside of frame**

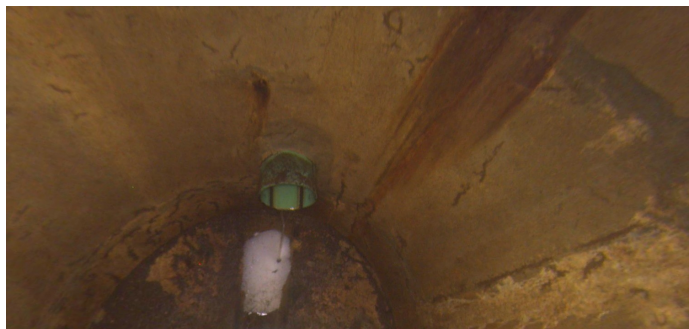
Code: **IW**
Description: **Infil Weeper**

Distance (ft): **11.8**
Structural Grade: **0**
O&M Grade: **2**
Clock Start/From: **12**
Clock To: **2**
1st Value:
2nd Value:
Value Percent:
Step: **NO**
Remarks:

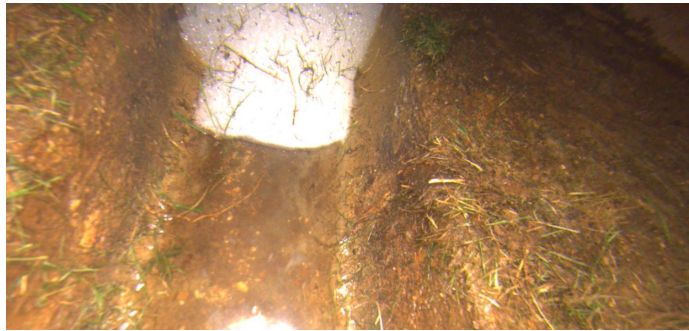
Code: **DSF**
Description: **Deposits Settled Fine**

Distance (ft): **16.1**
Structural Grade: **0**
O&M Grade: **2**
Clock Start/From: **12**
Clock To: **12**
1st Value:
2nd Value:
Value Percent: **5.000**
Step: **NO**
Remarks:

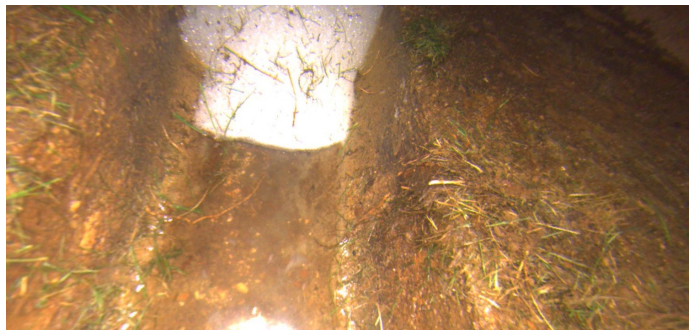
Code: **SRI**
Description: **Surface Roughness Increased**

Distance (ft): **16.1**
Structural Grade: **1**
O&M Grade: **0**
Clock Start/From: **12**
Clock To: **12**
1st Value:
2nd Value:
Value Percent:
Step: **NO**
Remarks:

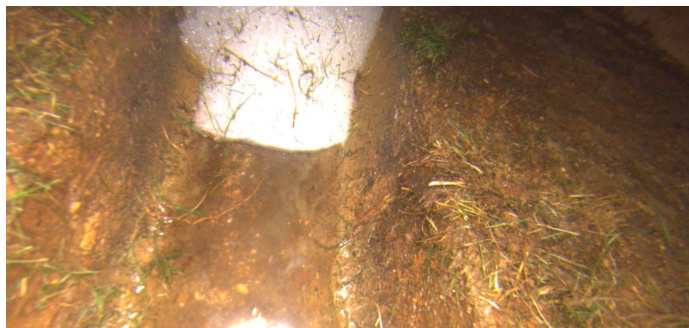
Code: **MGO**
Description: **General Observation**

Distance (ft): **16.1**
Structural Grade: **0**
O&M Grade: **0**
Clock Start/From:
Clock To:
1st Value:
2nd Value:
Value Percent:
Step: **NO**
Remarks: **end of survey**
