Manhole Inspection Report

Date:	04/22/2018	Weather:		Coding:	RZMACP
MH#:	M-1006-003	Owner:	NA	Len. Surveyed:	11.8
P.O.#:		Surveyor:	John Kuglmaier	Rim to Invert:	11.8
Customer:	8.7	Cert. #:	U-1215-07002349	Wall Material:	Concrete (reinforced)

Street:	Vermillion St. 235' South of 9th Pl.	Project:	Hobart, IN
City:	Hobart, IN	GPS Northing:	0.0
Location:		GPS Easting:	0.0
Drain Area:	Southeast	GPS Accuracy:	Nearest Meter
Cover Shape:	Circular	Evidence of Surcharge:	No
Cover Size:	22.5	Potential for Runoff:	None
Comments:

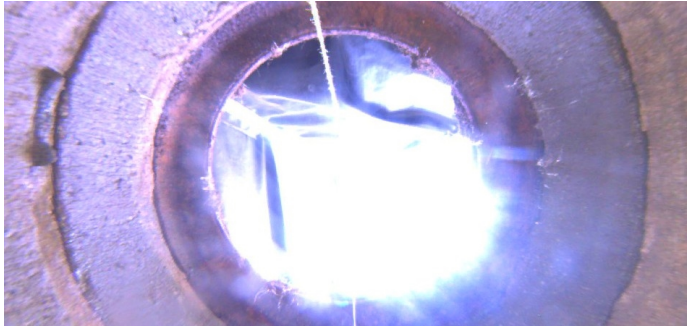
Code:	MGP
Description:	General Photo
Distance (ft):	2.7
Structural Grade:	0
O&M Grade:	0
Clock Start/From:	
Clock To:	
1st Value:	
2nd Value:	
Value Percent:	
Step:	NO
Remarks:

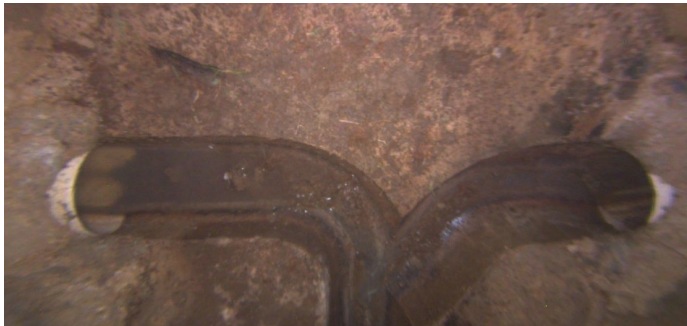
Code:	MGO
Description:	General Observation
Distance (ft):	10.6
Structural Grade:	0
O&M Grade:	0
Clock Start/From:	
Clock To:	
1st Value:	
2nd Value:	
Value Percent:	
Step:	NO
Remarks:	Ins. Comp.
