Manhole Inspection Report

Date:	04/22/2018	Weather:		Coding:	RZMACP
MH#:	M-1006-004	Owner:	NA	Len. Surveyed:	12.4
P.O.#:		Surveyor:	John Kuglmaier	Rim to Invert:	13.5
Customer:	8.7	Cert. #:	U-1215-07002349	Wall Material:	Concrete (reinforced)

Street:	Intersection of 10th St. and Vermilli	Project:	Hobart, IN
City:	Hobart, IN	GPS Northing:	0.0
Location:		GPS Easting:	0.0
Drain Area:	Southeast	GPS Accuracy:	Nearest Meter
Cover Shape:	Circular	Evidence of Surcharge:	No
Cover Size:	22.5	Potential for Runoff:	None
Comments:

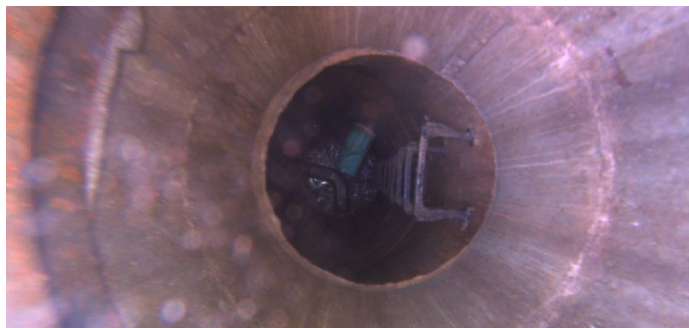
Code: **MGP**
 Description: **General Photo**

Distance (ft): **.0**
 Structural Grade: **0**
 O&M Grade: **0**
 Clock Start/From:
 Clock To:
 1st Value:
 2nd Value:
 Value Percent:
 Step: **NO**
 Remarks:

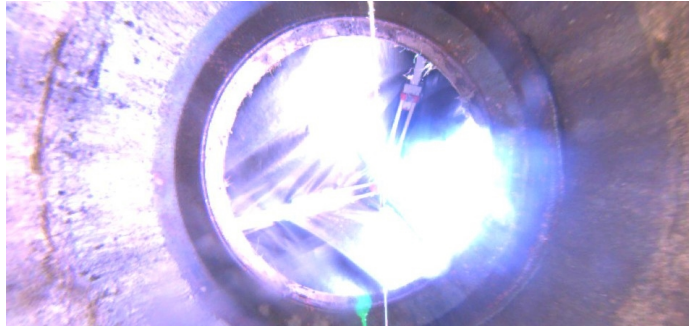
Code: **MGP**
Description: **General Photo**

Distance (ft): **2.5**
Structural Grade: **0**
O&M Grade: **0**
Clock Start/From:
Clock To:
1st Value:
2nd Value:
Value Percent:
Step: **NO**
Remarks:

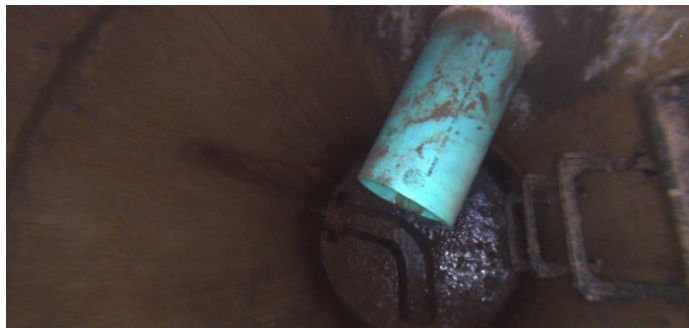
Code: **IS**
Description: **Infil Stain**

Distance (ft): **7.8**
Structural Grade: **0**
O&M Grade: **0**
Clock Start/From: **10**
Clock To:
1st Value:
2nd Value:
Value Percent:
Step: **NO**
Remarks:

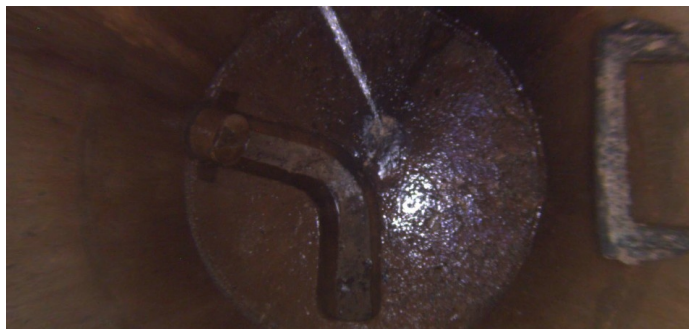
Code: **DSF**
Description: **Deposits Settled Fine**

Distance (ft): **10.8**
Structural Grade: **0**
O&M Grade: **2**
Clock Start/From: **12**
Clock To: **12**
1st Value:
2nd Value:
Value Percent: **5.000**
Step: **NO**
Remarks:

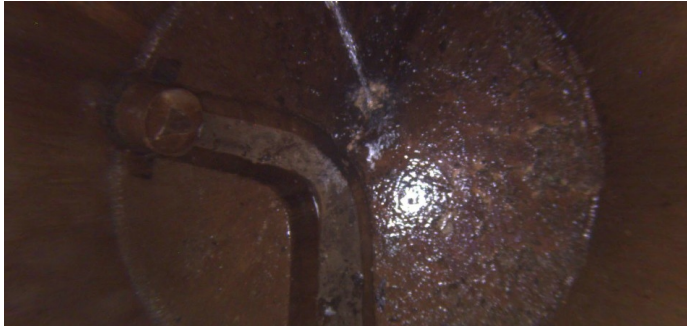
Code:	MGO
Description:	General Observation
Distance (ft):	11.9
Structural Grade:	0
O&M Grade:	0
Clock Start/From:	
Clock To:	
1st Value:	
2nd Value:	
Value Percent:	
Step:	NO
Remarks:	Ins. Comp.
