Manhole Inspection Report

Date:	04/22/2018	Weather:		Coding:	RZMACP
MH#:	M-1006-006	Owner:	NA	Len. Surveyed:	6.9
P.O.#:		Surveyor:	John Kuglmaier	Rim to Invert:	7.1
Customer:	8.7	Cert. #:	U-1215-07002349	Wall Material:	Concrete (reinforced)

Street:	Intersection of Vermillion St. and 9t	Project:	Hobart, IN
City:	Hobart, IN	GPS Northing:	0.0
Location:		GPS Easting:	0.0
Drain Area:	Southeast	GPS Accuracy:	Nearest Meter
Cover Shape:	Circular	Evidence of Surcharge:	No
Cover Size:	22.5	Potential for Runoff:	None
Comments:

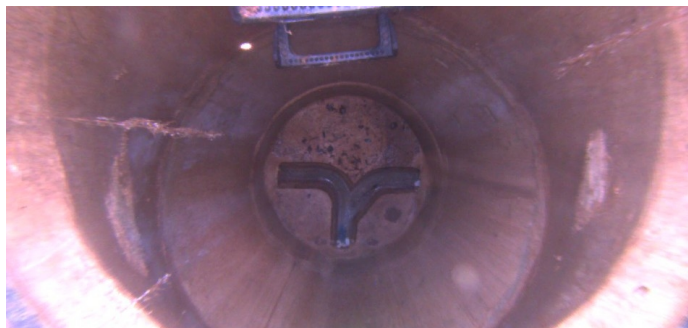
Code: **MGP**
Description: **General Photo**

Distance (ft): **.0**
Structural Grade: **0**
O&M Grade: **0**
Clock Start/From:
Clock To:
1st Value:
2nd Value:
Value Percent:
Step: **NO**
Remarks:

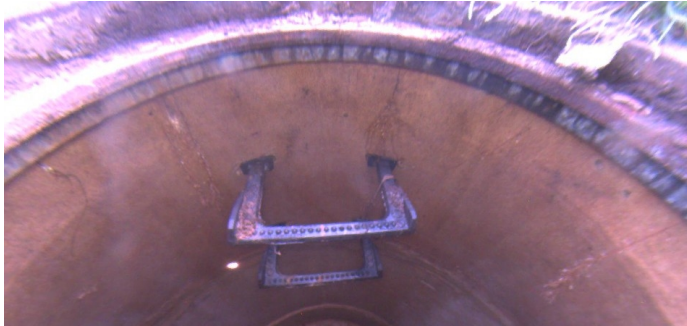
Code: **RFJ**
Description: **Roots Fine Joint**

Distance (ft): **.0**
Structural Grade: **0**
O&M Grade: **1**
Clock Start/From: **12**
Clock To: **12**
1st Value:
2nd Value:
Value Percent:
Step: **NO**
Remarks:

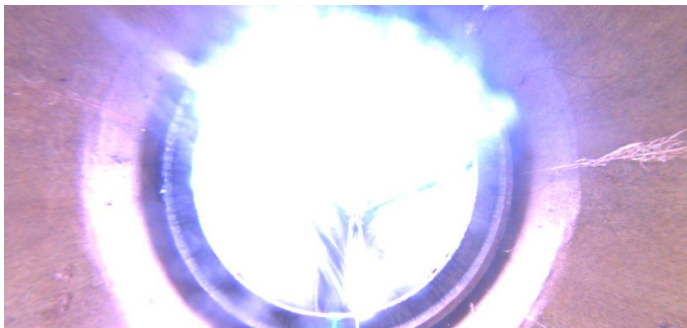
Code: **MGP**
Description: **General Photo**

Distance (ft): **2.5**
Structural Grade: **0**
O&M Grade: **0**
Clock Start/From:
Clock To:
1st Value:
2nd Value:
Value Percent:
Step: **NO**
Remarks:

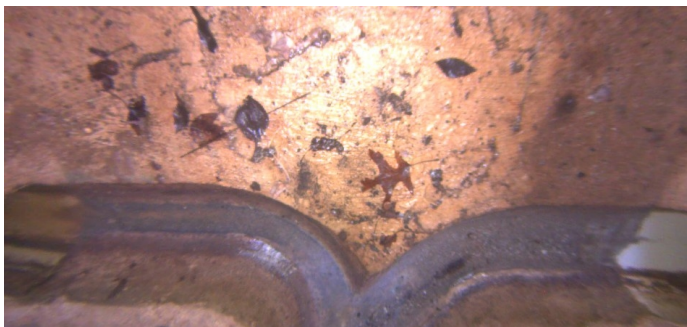
Code: **MGO**
Description: **General Observation**

Distance (ft): **6.0**
Structural Grade: **0**
O&M Grade: **0**
Clock Start/From:
Clock To:
1st Value:
2nd Value:
Value Percent:
Step: **NO**
Remarks: **Ins. Comp.**
