# Manhole Inspection Report

Date:	<b>04/22/2018</b>	Weather:		Coding:	<b>RZMACP</b>
MH#:	<b>M-1006-007</b>	Owner:	<b>NA</b>	Len. Surveyed:	<b>5.9</b>
P.O.#:		Surveyor:	<b>John Kuglmaier</b>	Rim to Invert:	<b>5.9</b>
Customer:	<b>8.7</b>	Cert. #:	<b>U-1215-07002349</b>	Wall Material:	<b>Concrete (reinforced)</b>

Street:	<b>9th Pl. 314' East of Vermillion St.</b>	Project:	<b>Hobart, IN</b>
City:	<b>Hobart, IN</b>	GPS Northing:	<b>0.0</b>
Location:		GPS Easting:	<b>0.0</b>
Drain Area:	<b>Southeast</b>	GPS Accuracy:	<b>Nearest Meter</b>
Cover Shape:	<b>Circular</b>	Evidence of Surcharge:	<b>No</b>
Cover Size:	<b>22.5</b>	Potential for Runoff:	<b>None</b>
Comments:

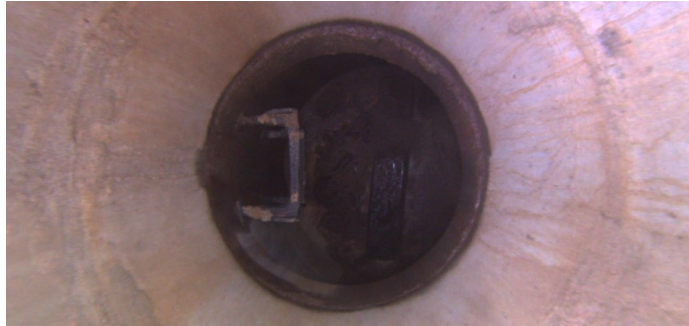
Code: **IS**  
Description: **Infil Stain**

Distance (ft): **.7**  
Structural Grade: **0**  
O&M Grade: **0**  
Clock Start/From: **12**  
Clock To: **12**  
1st Value:  
2nd Value:  
Value Percent:  
Step: **NO**  
Remarks:

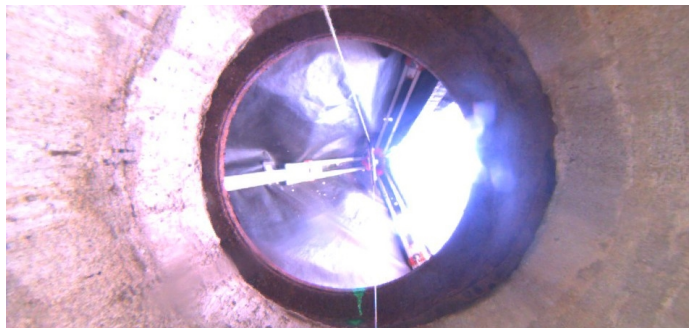
Code: **MGP**  
Description: **General Photo**

Distance (ft): **2.5**  
Structural Grade: **0**  
O&M Grade: **0**  
Clock Start/From:  
Clock To:  
1st Value:  
2nd Value:  
Value Percent:  
Step: **NO**  
Remarks:

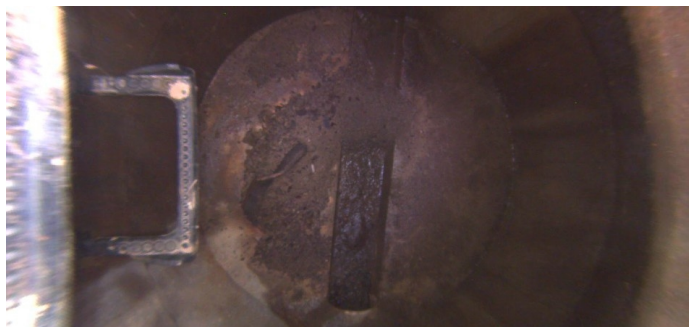
Code: **DAZ**  
Description: **Deposits Attached Other**

Distance (ft): **2.9**  
Structural Grade: **0**  
O&M Grade: **2**  
Clock Start/From: **12**  
Clock To: **12**  
1st Value:  
2nd Value:  
Value Percent: **5.000**  
Step: **NO**  
Remarks: **Mixed materials**

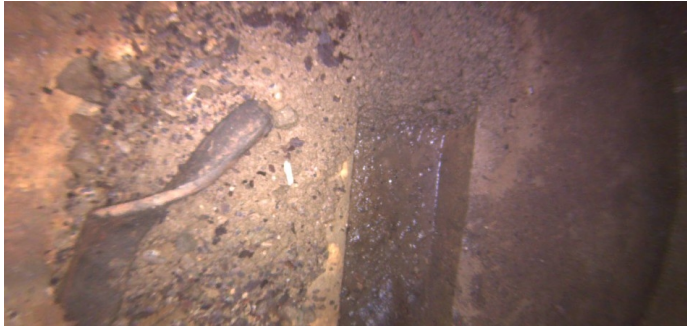
Code:	<b>MGO</b>
Description:	<b>General Observation</b>
Distance (ft):	<b>5.1</b>
Structural Grade:	<b>0</b>
O&M Grade:	<b>0</b>
Clock Start/From:	
Clock To:	
1st Value:	
2nd Value:	
Value Percent:	
Step:	<b>NO</b>
Remarks:	<b>Ins. Comp.</b>
