Manhole Inspection Report

| MH#: | M-1006-011 | Owner: | NA | Len. Surveyed: | 9.8 |

| Street: | N of Hwy 130. 1373' East of Sullivan | Project: | Hobart, IN |

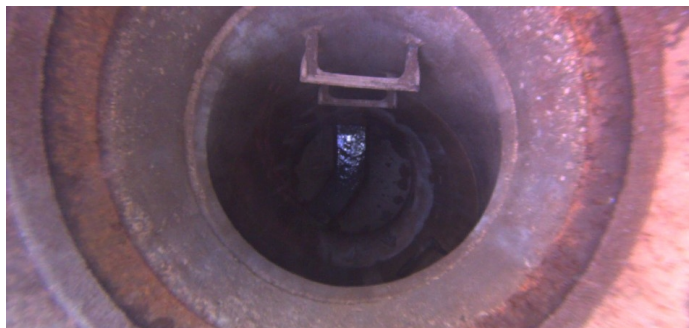
Code: **MGP**
Description: **General Photo**

Distance (ft): **.0**
Structural Grade: **0**
O&M Grade: **0**
Clock Start/From:
Clock To:
1st Value:
2nd Value:
Value Percent:
Step: **NO**
Remarks:

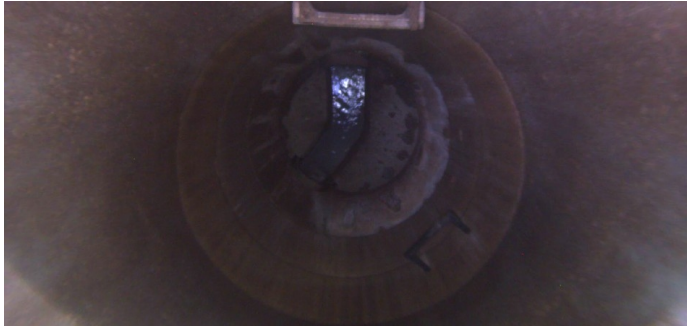
| | Position | Code | Observation | Video (sec) | Grade |
|--|---|---|---|---|---|
| | 1.4 | IS | Infil Stain | 24 | NA |

Code: **IS**
Description: **Infil Stain**

Distance (ft): **1.4**
Structural Grade: **0**
O&M Grade: **0**
Clock Start/From: **12**
Clock To: **12**
1st Value:
2nd Value:
Value Percent:
Step: **NO**
Remarks:

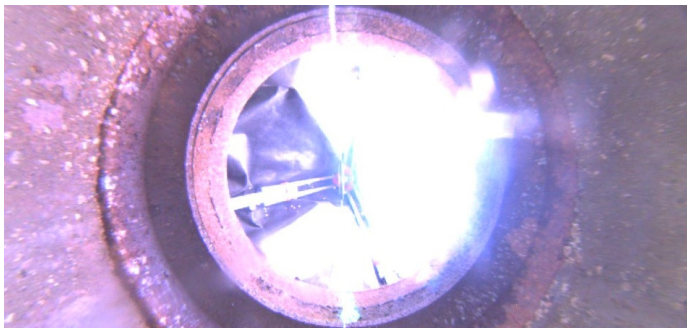
Code: **MGP**
Description: **General Photo**

Distance (ft): **2.8**
Structural Grade: **0**
O&M Grade: **0**
Clock Start/From:
Clock To:
1st Value:
2nd Value:
Value Percent:
Step: **NO**
Remarks:

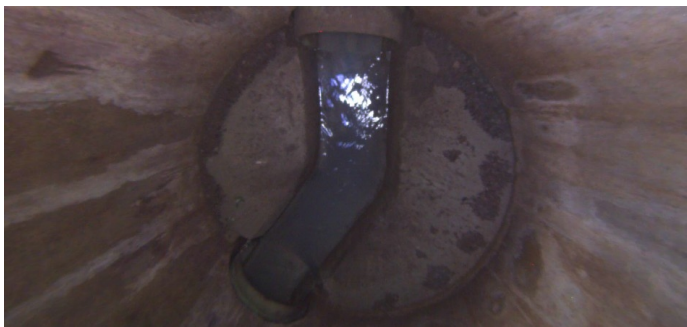
| | Position | Code | Observation | Video (sec) | Grade |
|--|---|---|---|---|---|
| | 6.2 | DSF | Deposits Settled Fine | 62 | M 2 |

Code: **DSF**
Description: **Deposits Settled Fine**

Distance (ft): **6.2**
Structural Grade: **0**
O&M Grade: **2**
Clock Start/From: **12**
Clock To: **12**
1st Value:
2nd Value:
Value Percent: **5.000**
Step: **NO**
Remarks:

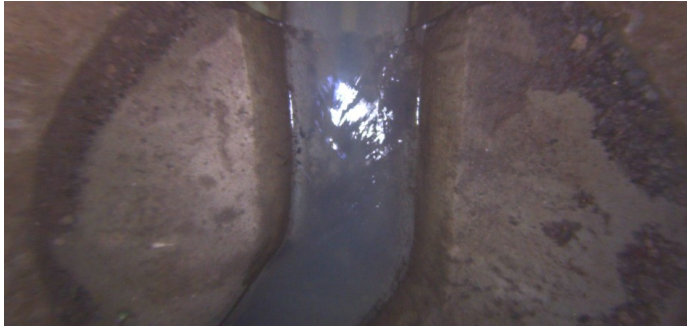
| Code: | MGO |
| Description: | General Observation |
| Distance (ft): | 8.3 |
| Remarks: | Ins. Comp. |
