Manhole Inspection Report

Date:	04/22/2018	Weather:		Coding:	RZMACP
MH#:	M-1006-013	Owner:	NA	Len. Surveyed:	10.4
P.O.#:		Surveyor:	John Kuglmaier	Rim to Invert:	11.5
Customer:	8.7	Cert. #:	U-1215-07002349	Wall Material:	Concrete (reinforced)

Street:	The North Side of Hwy 130. 946' Eas	Project:	Hobart, IN
City:	Hobart, IN	GPS Northing:	0.0
Location:		GPS Easting:	0.0
Drain Area:	Southeast	GPS Accuracy:	Nearest Meter
Cover Shape:	Circular	Evidence of Surcharge:	No
Cover Size:	22.5	Potential for Runoff:	None
Comments:

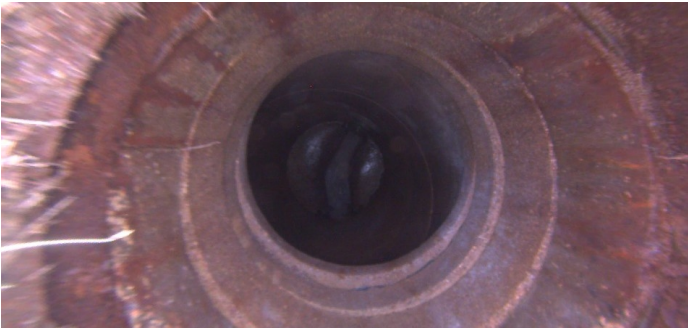
Code:

MGP

Description:

General Photo

Distance (ft):

.0

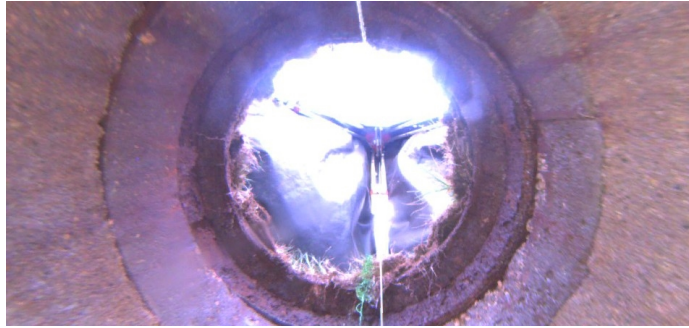
Code: **MGP**
Description: **General Photo**

Distance (ft): **2.8**
Structural Grade: **0**
O&M Grade: **0**
Clock Start/From:
Clock To:
1st Value:
2nd Value:
Value Percent:
Step: **NO**
Remarks:

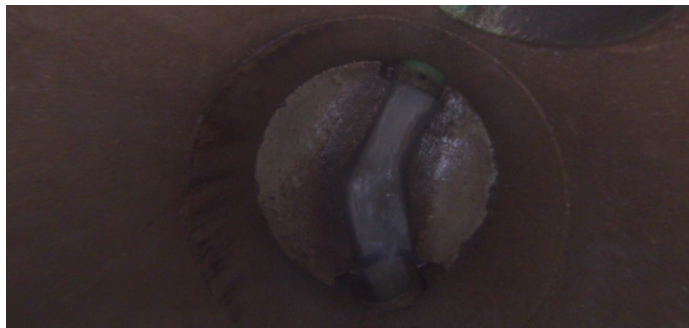
Code: **IS**
Description: **Infil Stain**

Distance (ft): **7.3**
Structural Grade: **0**
O&M Grade: **0**
Clock Start/From: **8**
Clock To: **11**
1st Value:
2nd Value:
Value Percent:
Step: **NO**
Remarks:

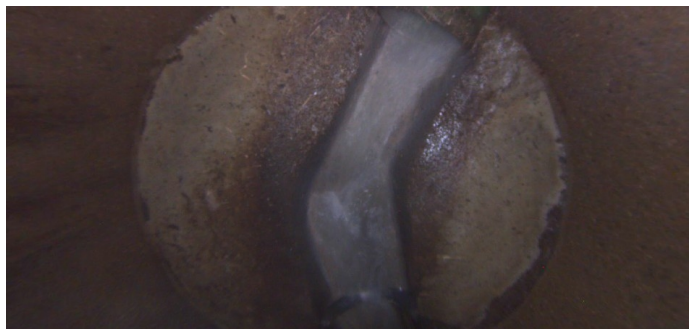
Code: **MGO**
Description: **General Observation**

Distance (ft): **9.4**
Structural Grade: **0**
O&M Grade: **0**
Clock Start/From:
Clock To:
1st Value:
2nd Value:
Value Percent:
Step: **NO**
Remarks: **Ins. Comp.**
